Most information available about concrete is written for contractors, for those who design concrete mixes, and for those who perform invasive testing. The information provided here is specifically for those who perform non-invasive, visual inspections of concrete, such as home inspectors or commercial property inspectors using the [International Standards of Practice for Inspecting Commercial Properties](#).

Constituent Material Properties

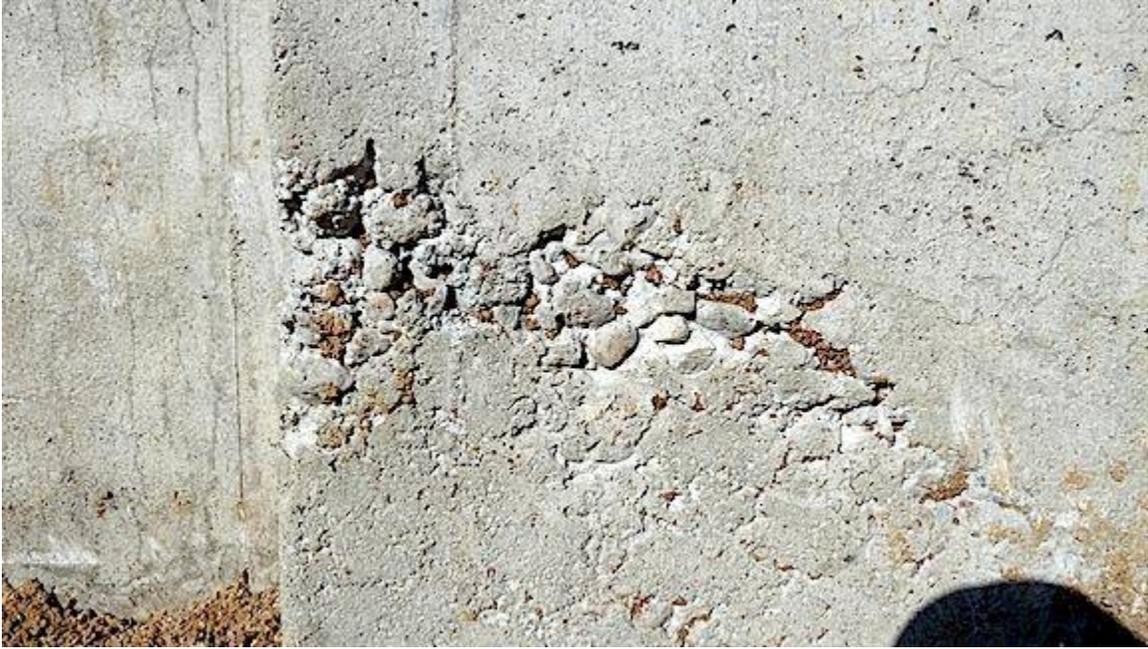
Honeycombing due to poor consolidation

- inadequate cover of reinforcement steel. Inadequate cover can lower steel's resistance to corrosion. This is a very common problem;
- incomplete consolidation. Concrete is usually consolidated with a mechanical vibrator. Concrete being placed in forms should be placed in layers, with each layer being vibrated when it is placed. Placing too much concrete at any one area at a time, or failing to vibrate concrete adequately can result in incomplete consolidation, causing a honeycomb pattern;

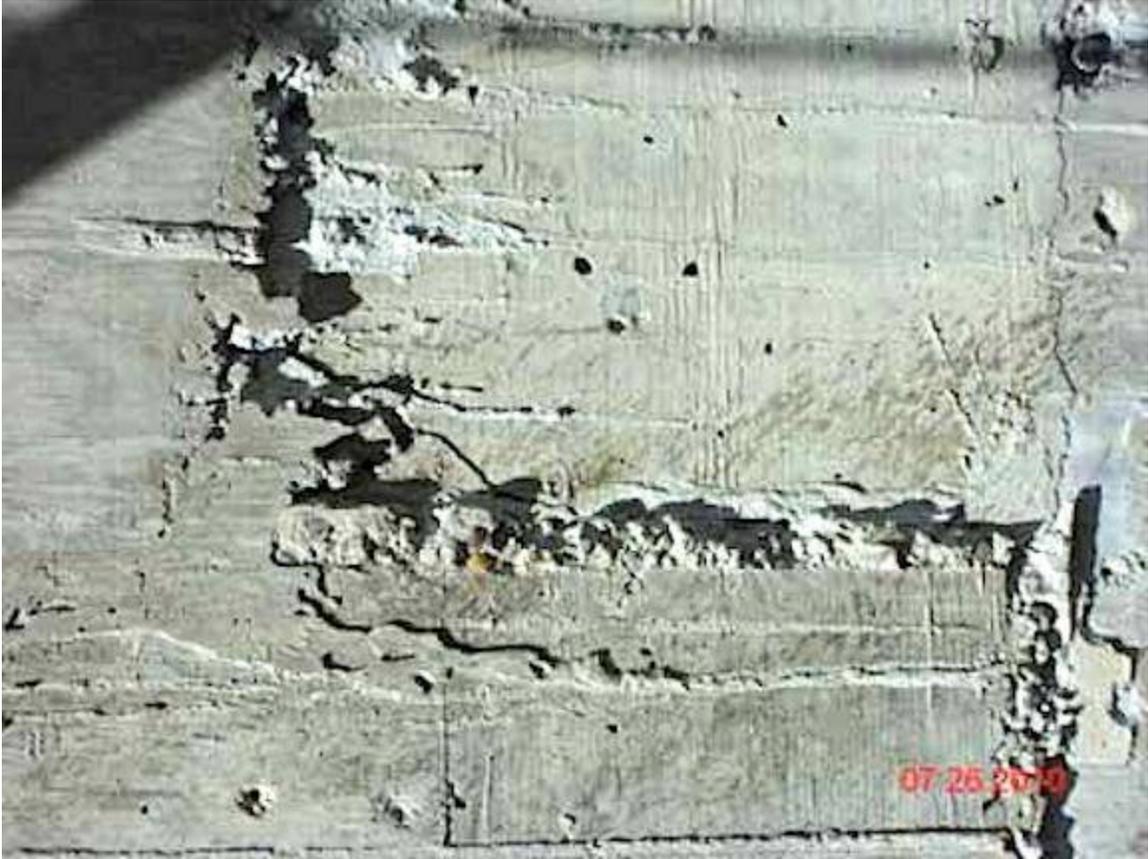
A cold joint in concrete

- creating cold joints. Cold joints are created when concrete is poured against concrete that has already hardened to some degree. This condition results in a weakened bond between the existing and the newly poured concrete;

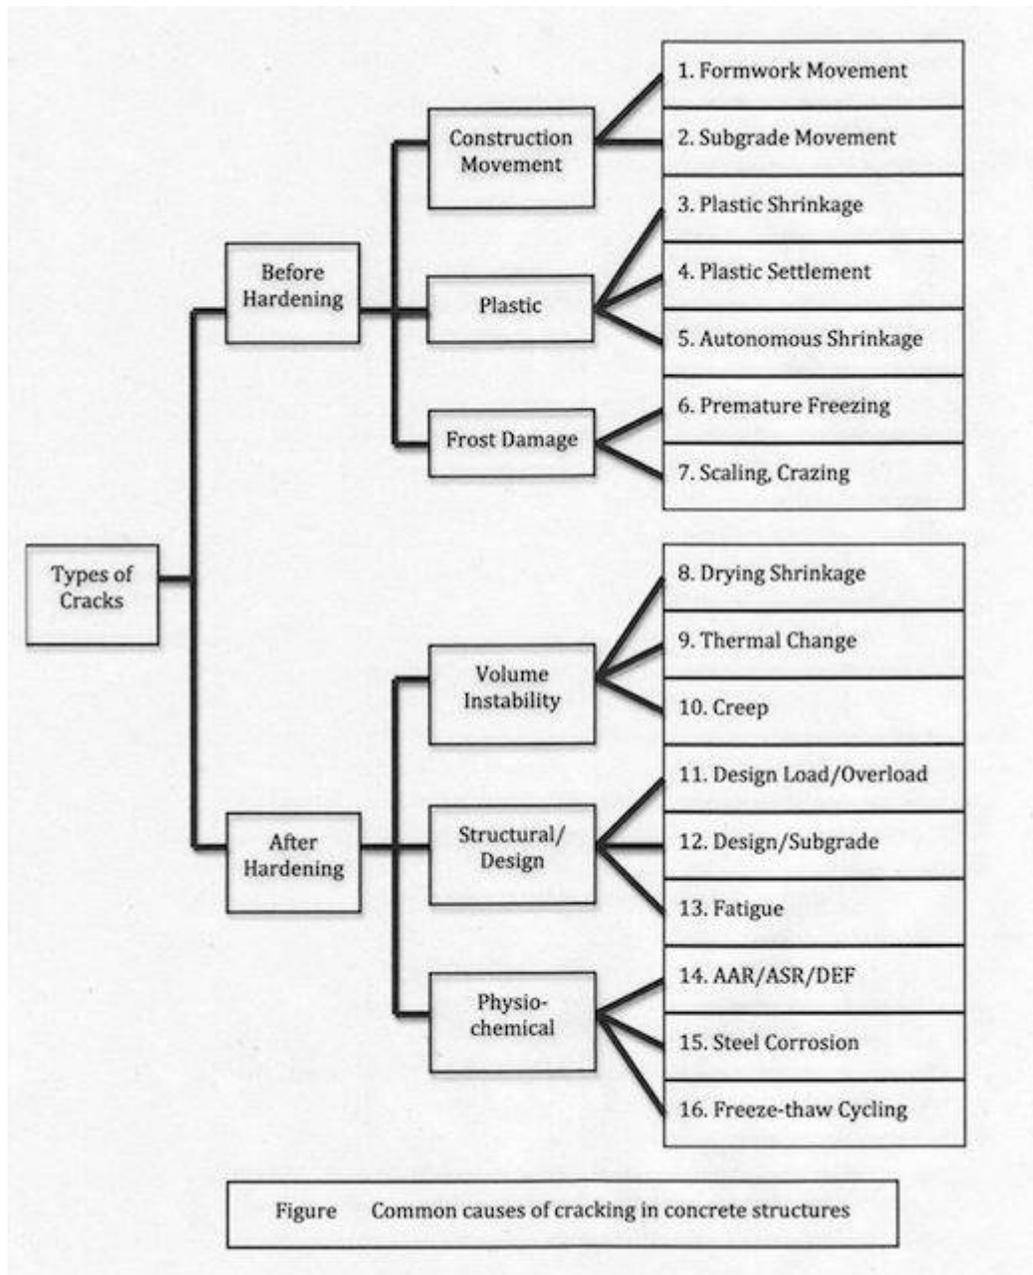
The chart below classifies cracks according to whether they appear before or after hardening.

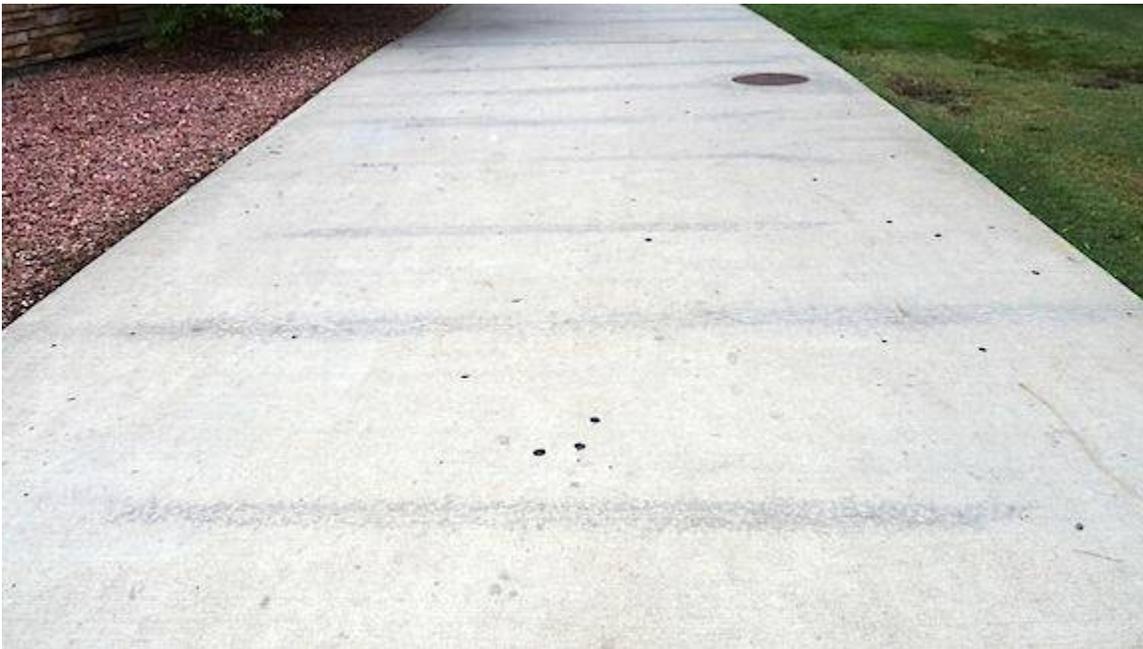
Plastic settlement cracking

Repeating pattern of cracks where rebar cross-members connect longitudinal rebar

As soon as concrete is placed, it begins to consolidate, and as bleed water rises to the surface, cement particles consolidate and the concrete settles. The settling process is restrained by reinforcement steel and, under certain circumstances, cracks will develop directly above the steel. This condition is best recognized by the crack pattern, which typically reflects the even spacing of the reinforcement steel.

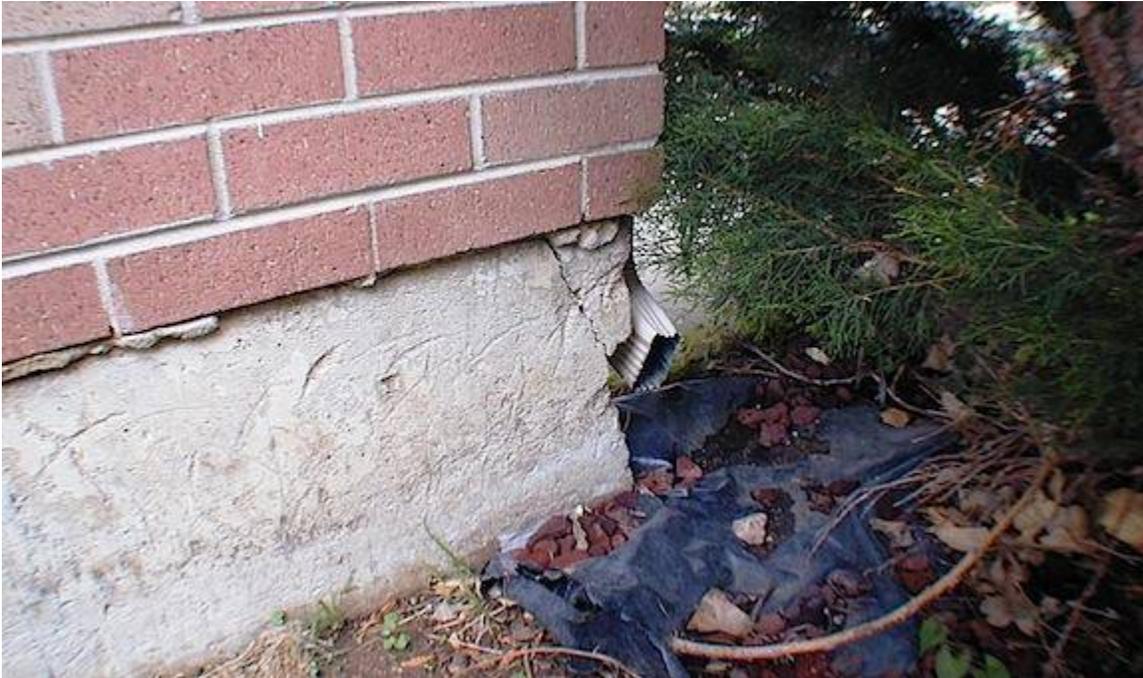
Outside corners are also high-stress points.

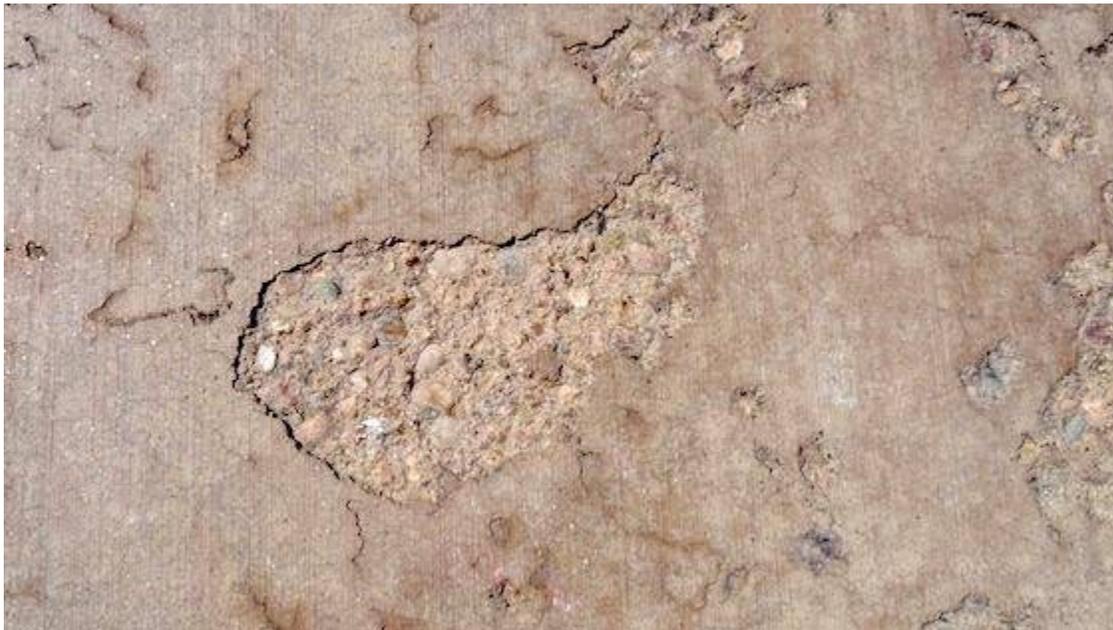
Small patches of flaking

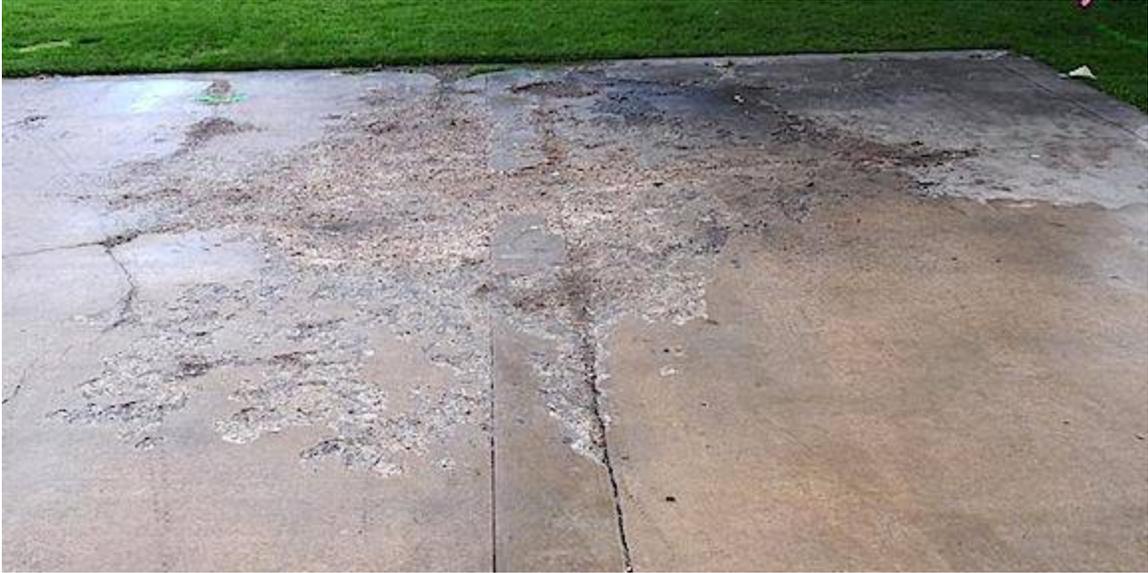
Smaller patches of damage have expanded to form a large area of damage.

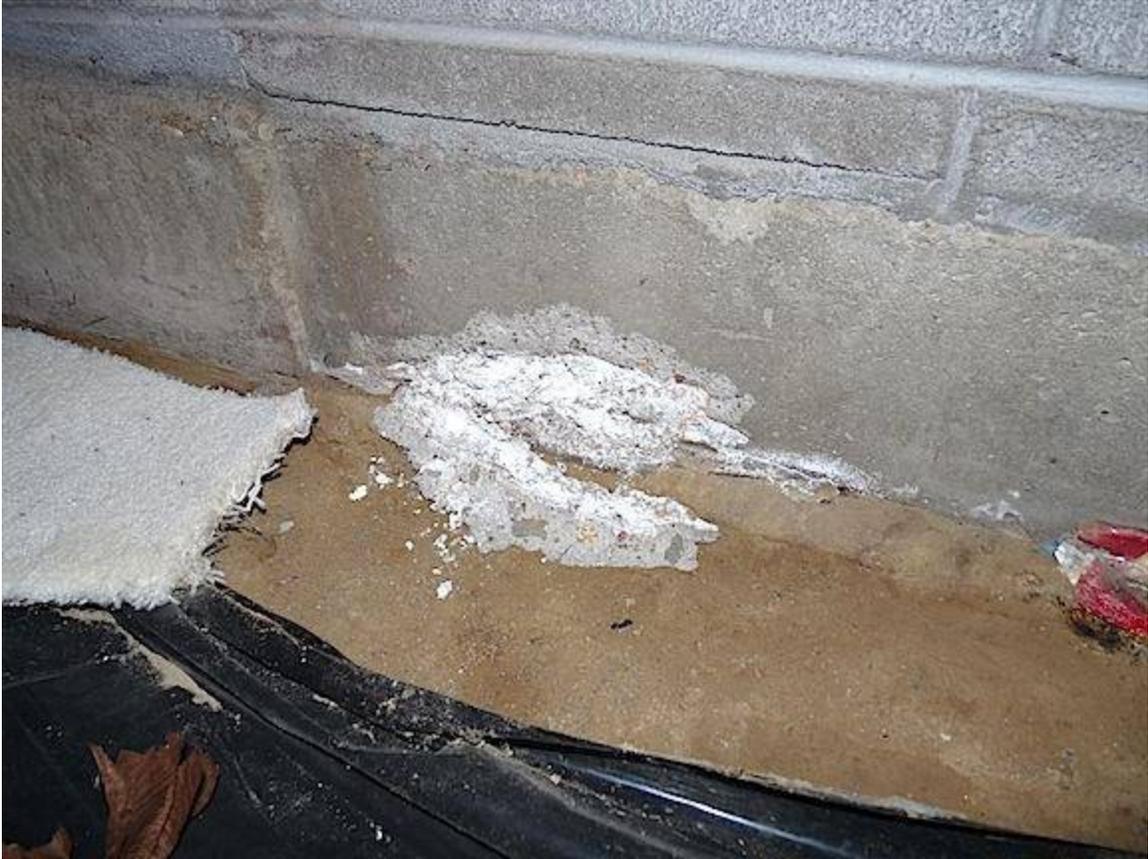
Flaking at a crawlspace footing

In the photo above, the flake has detached from the surface of the footing, which was caused by the expansion of a pocket of minerals in the concrete. Negative grade around the home caused the soil to become saturated. Moisture eventually diffused through the porous concrete, eventually reaching the expansive minerals. The clue that this was caused by moisture is the white mineral salts, called efflorescence.

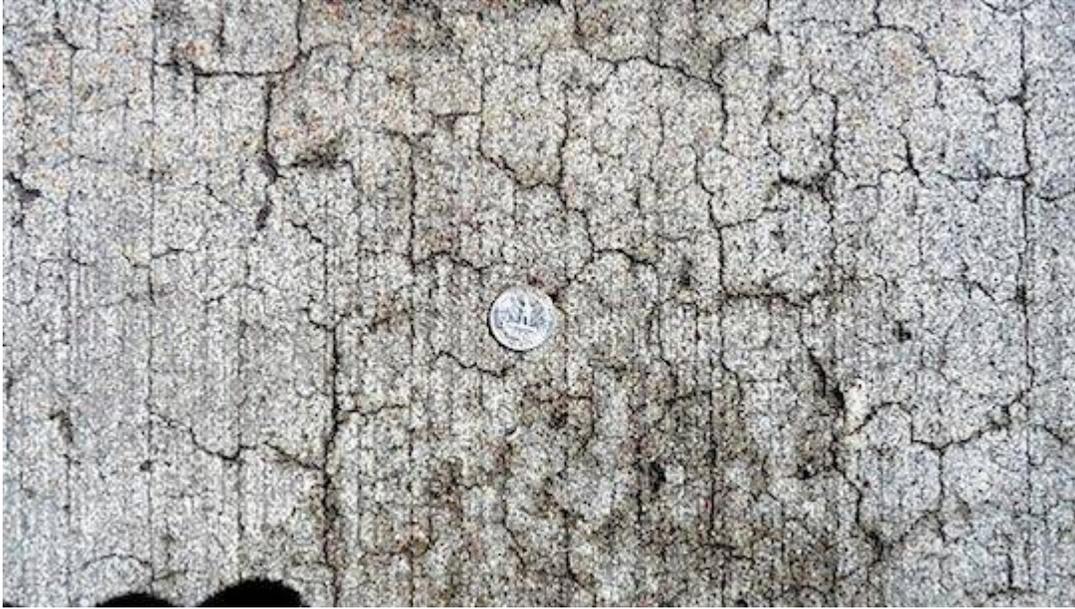
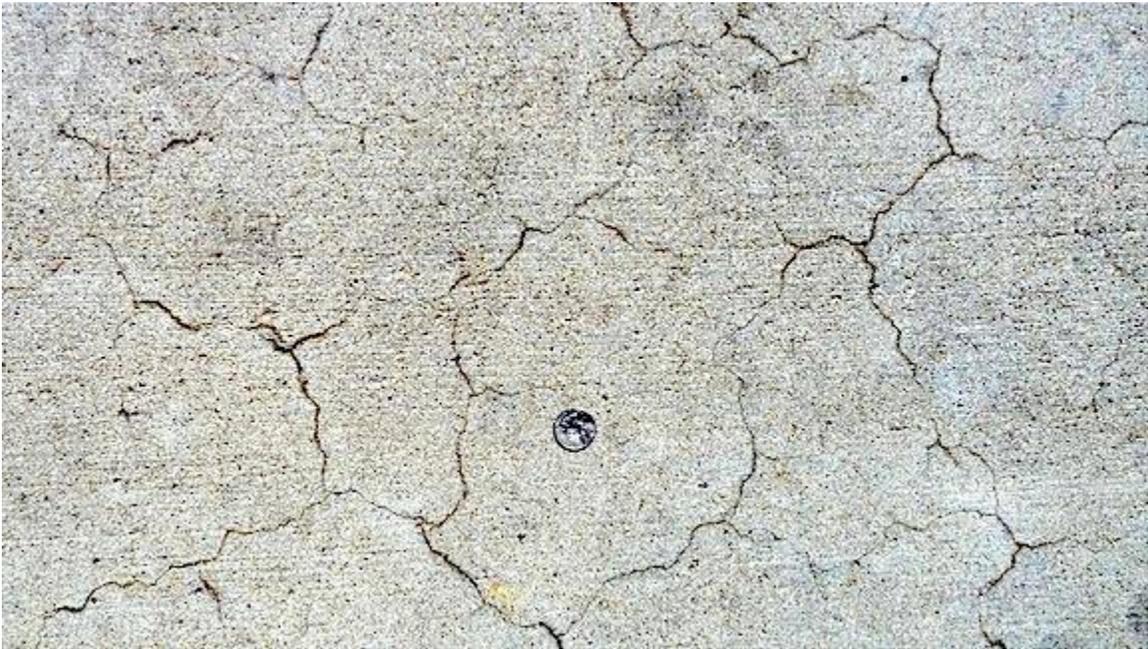
Pattern cracking, also called map cracking and craze cracking, appears as a network of random cracking on the concrete's surface. The cracking is usually shallow (less than 1/8-inch deep) and not a structural issue. It's seldom a durability problem but more of a cosmetic one.

The area enclosed by pattern cracking may be anywhere from 1/2-inch to 4 inches across.

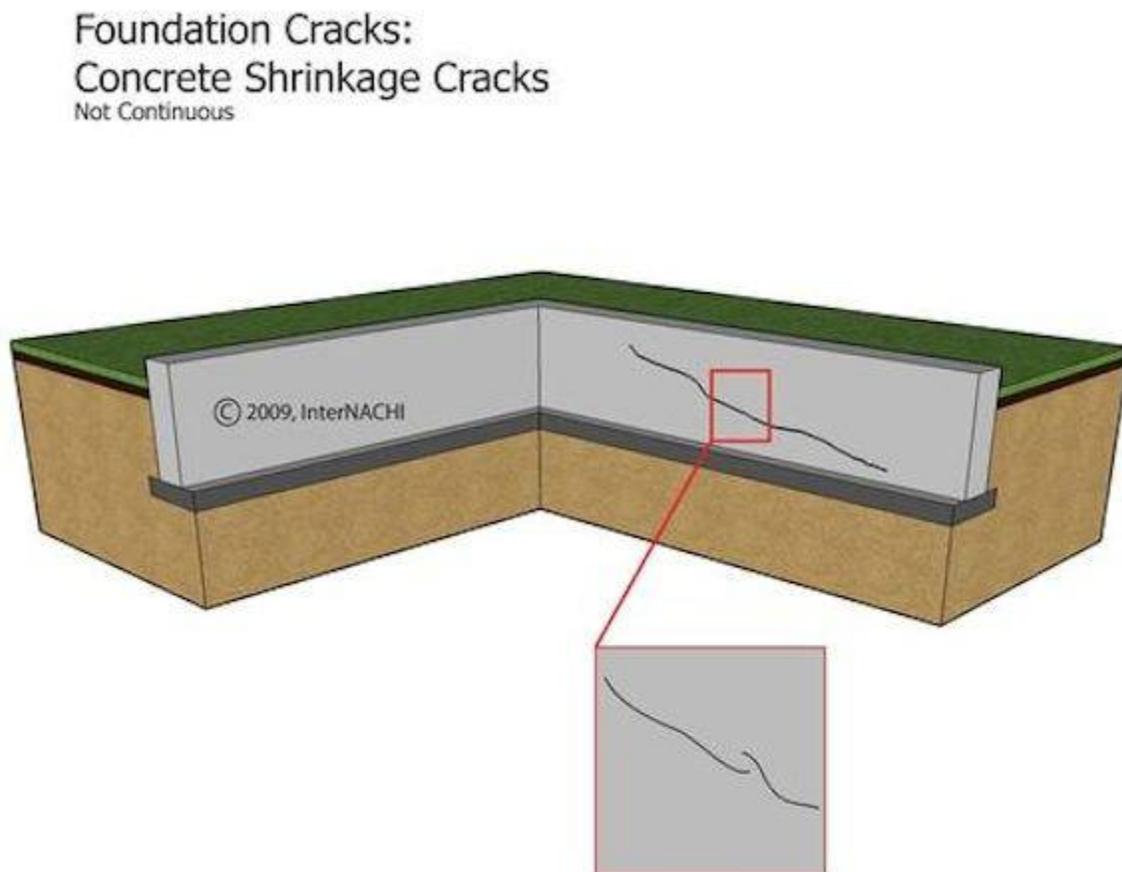
Wall shrinkage cracks are often diagonal and do not extend to the corners.

They are typically shallow and linear, although such cracks are not always continuous.

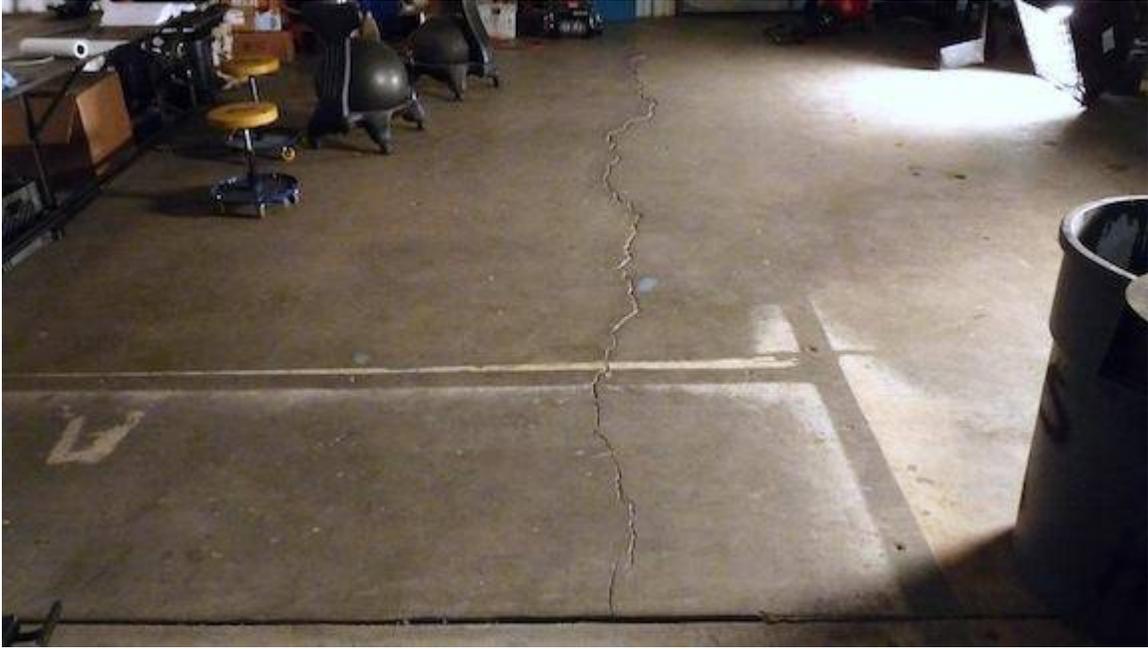
Notice the lack of control joints in this shrinkage crack.

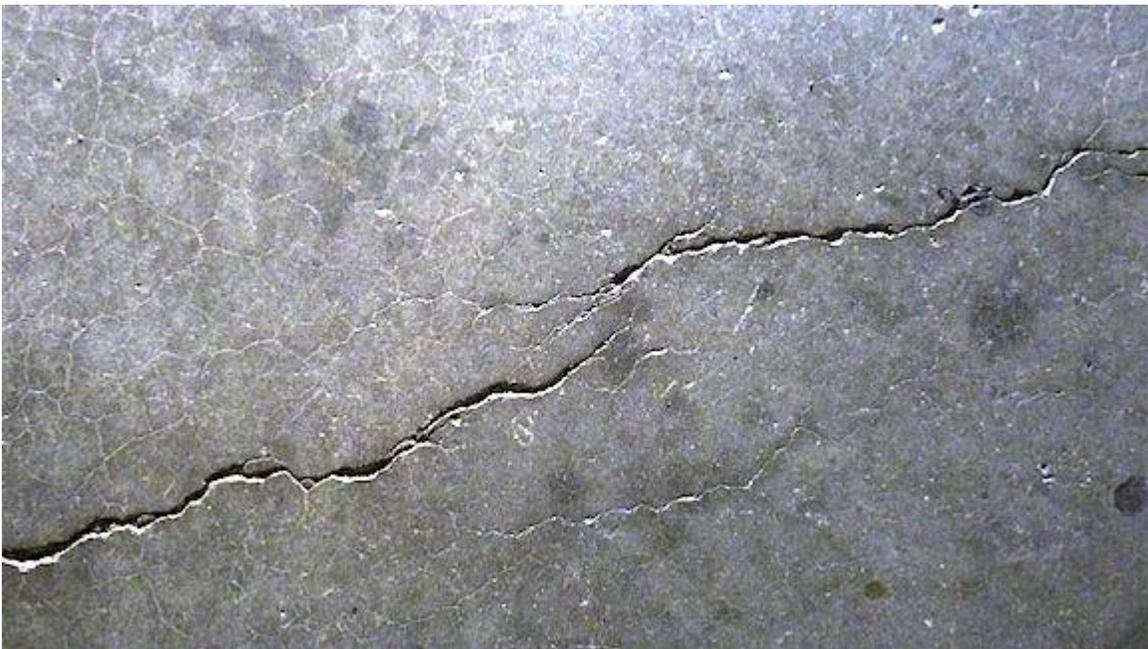
A typical interruption in a shrinkage crack

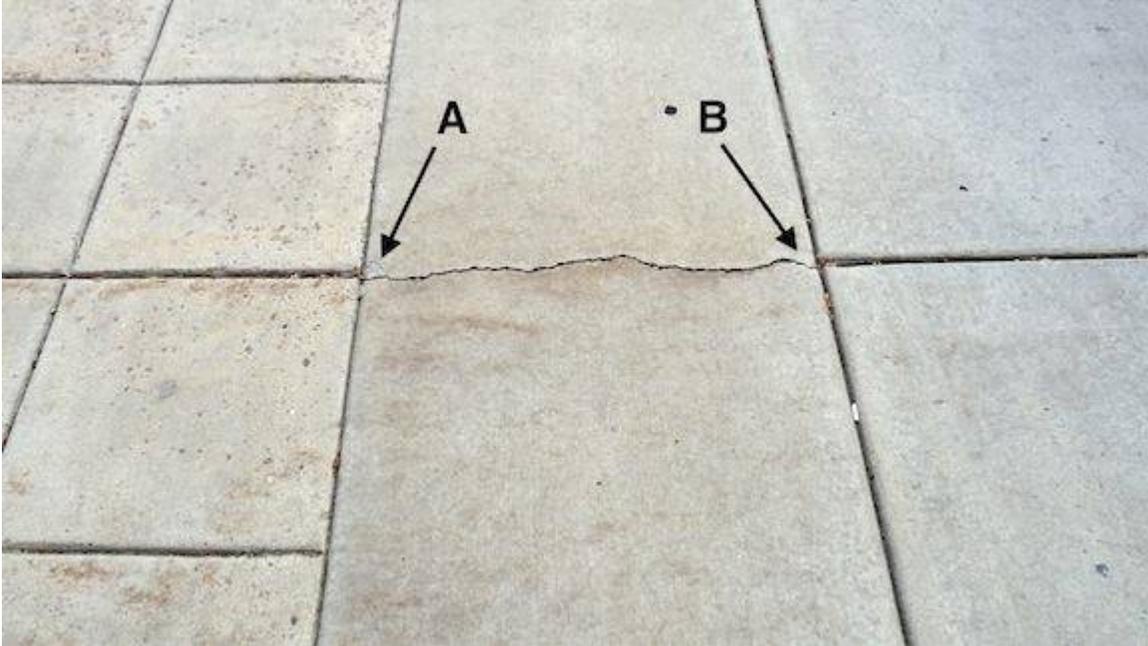
A transverse shrinkage crack in pavement extends between cracks located in control joints.

In the photo above, areas A and B were the points at which the highest stress developed due to adjacent cracking in the control joints, so that is where the walkway panel split first, following the path of greatest stress. As the slab continued to shrink, the two cracks connected with each other to form a single transverse crack.

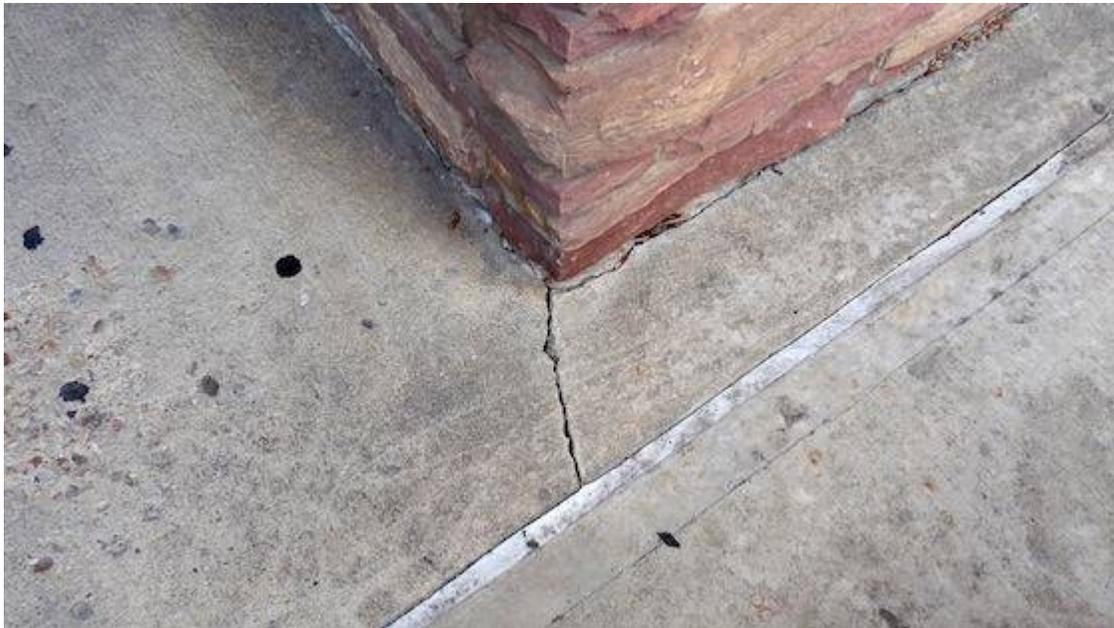
A re-entrant corner crack

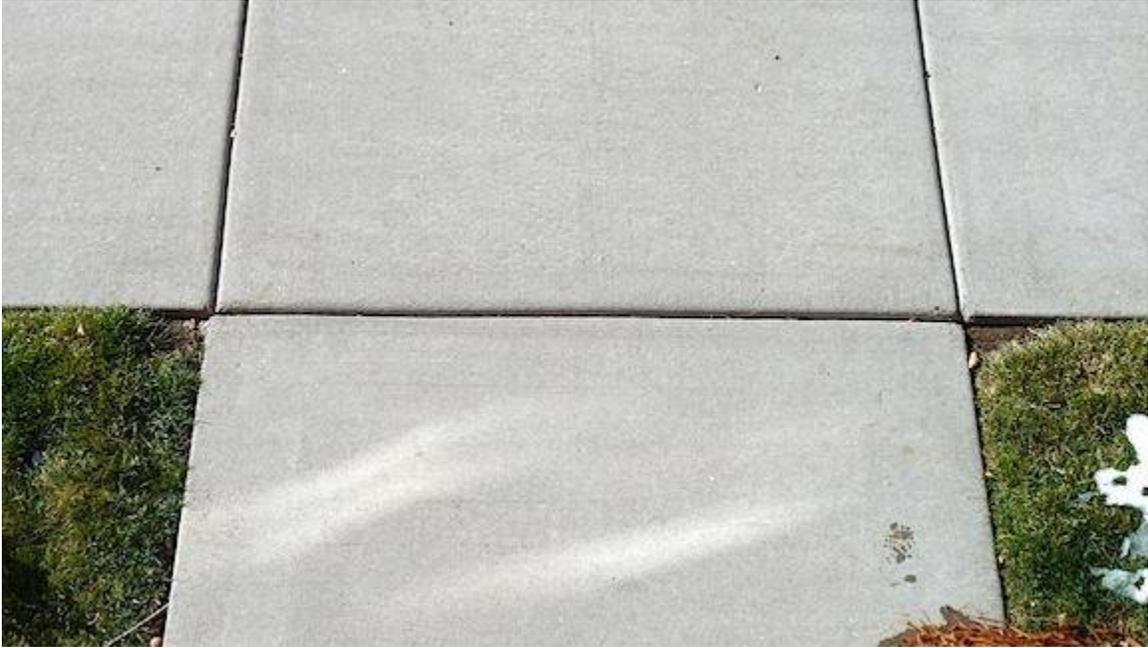
A re-entrant corner with properly placed control joints

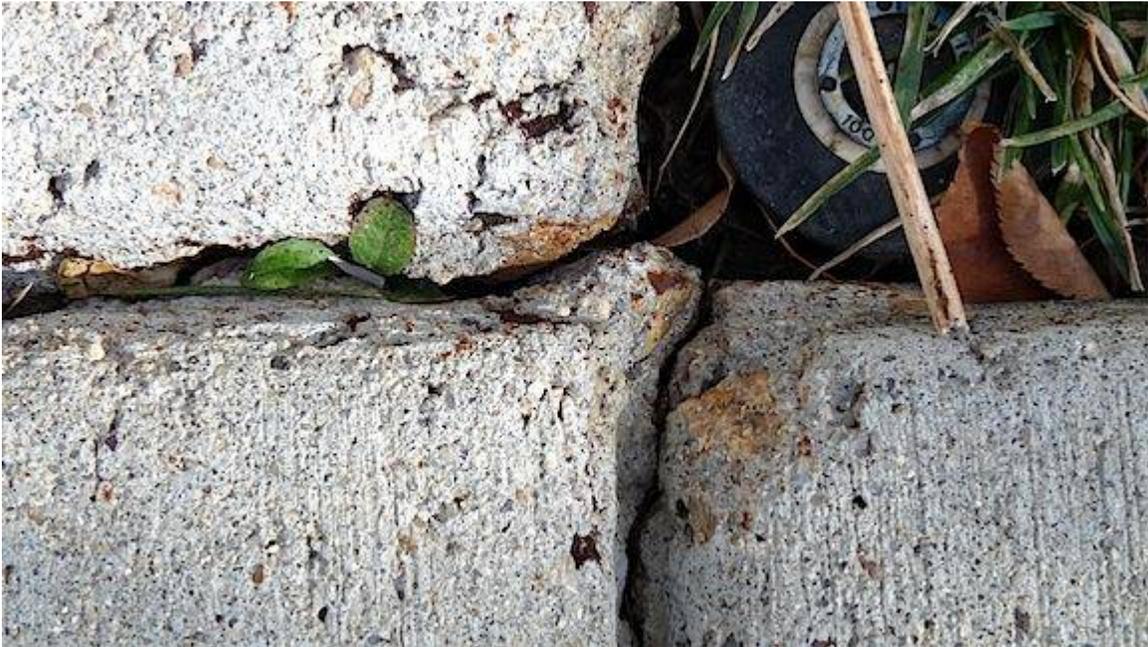
This close-up of the corner shows cracking taking place in the control joints, as it should.

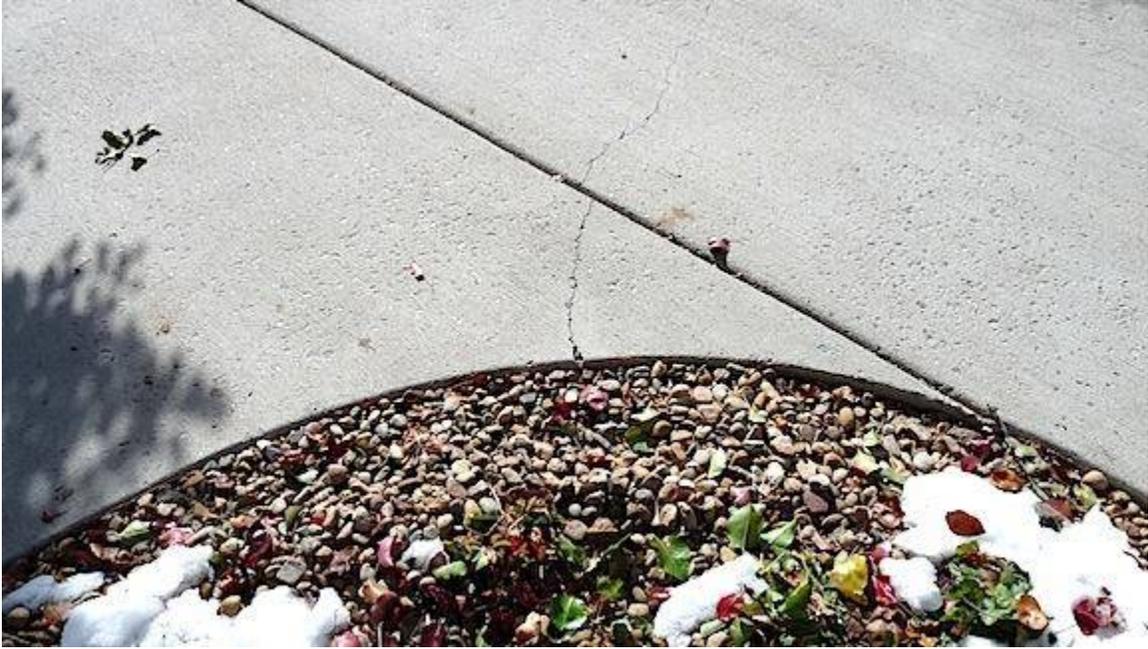
Re-entrant cracking at the apex of a radiused re-entrant corner

The photo above shows concrete cracking off the apex of a radiused re-entrant corner, even though there is a control joint located nearby.

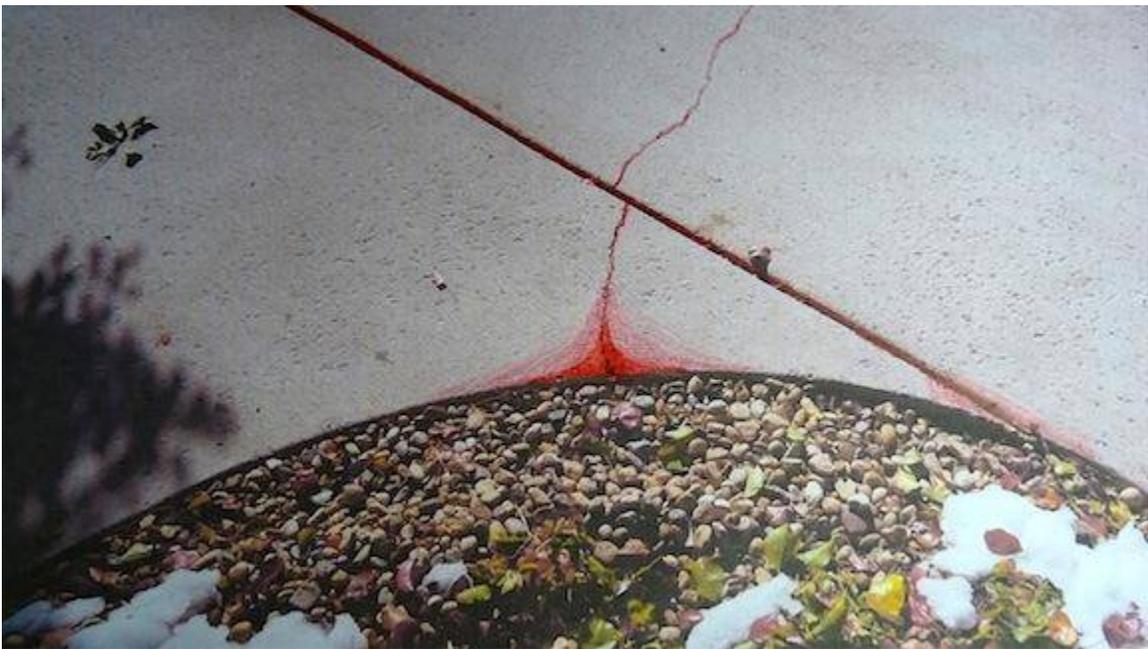
Red areas show approximate locations of stress concentrations

This image shows how steep stress gradients can be, or how concentrated stresses can be according to shape. If the stress gradient were shallower, the stress at the apex would be less concentrated and would have been relieved by cracking at the control joint.

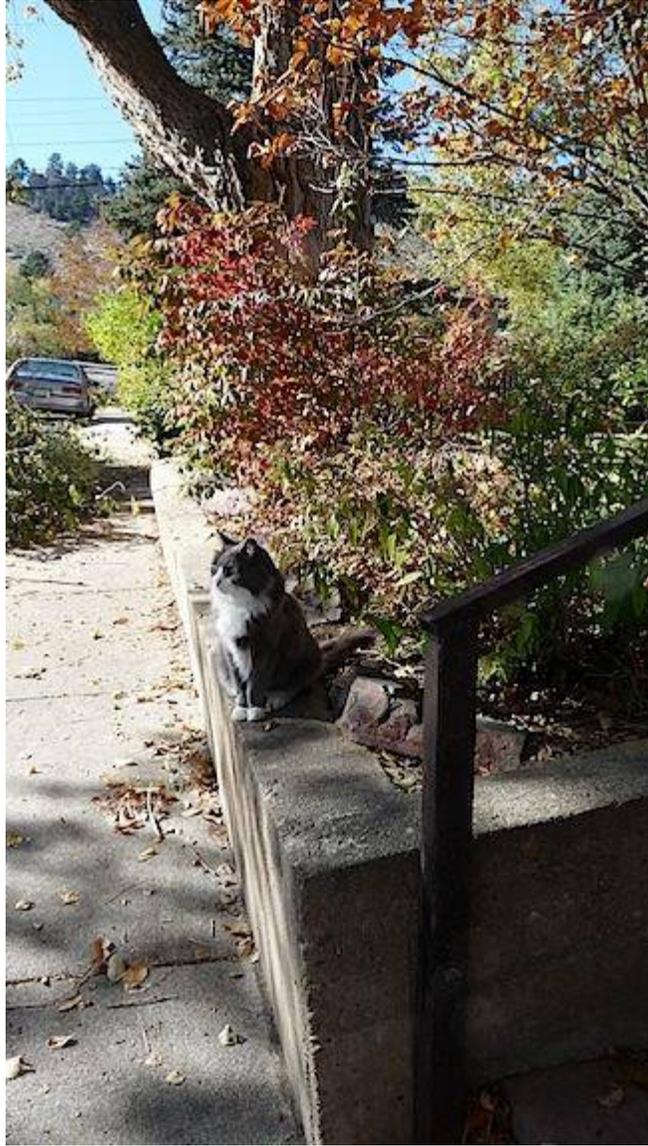
Creep

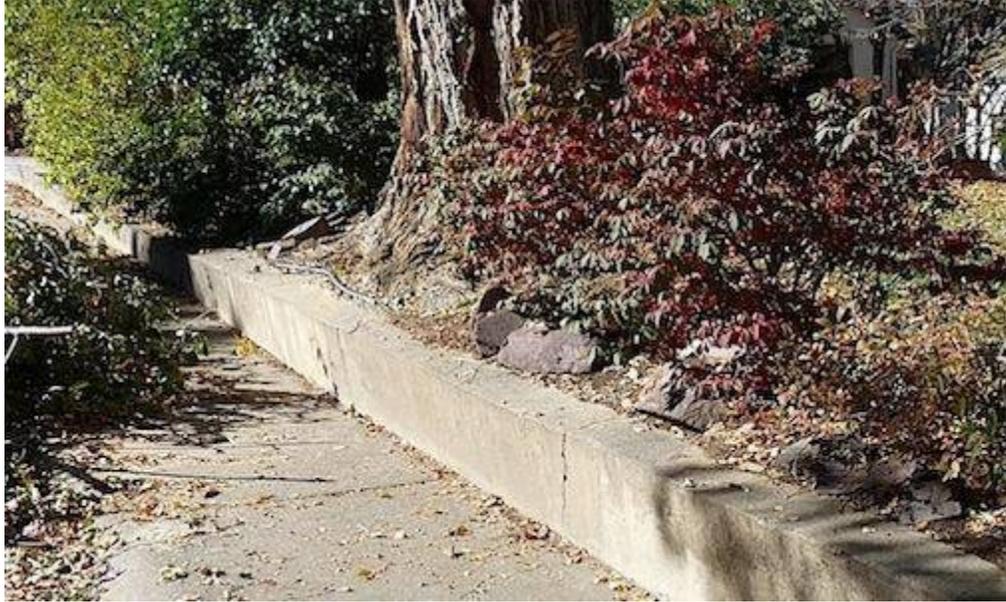
Creep with cracking

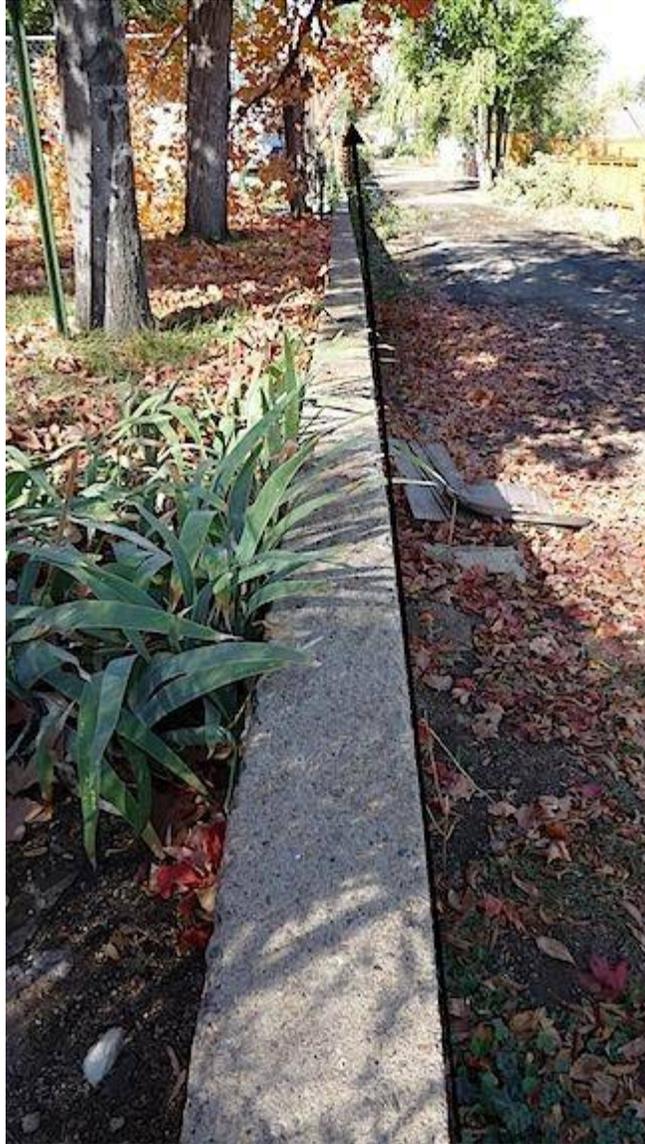
Creep

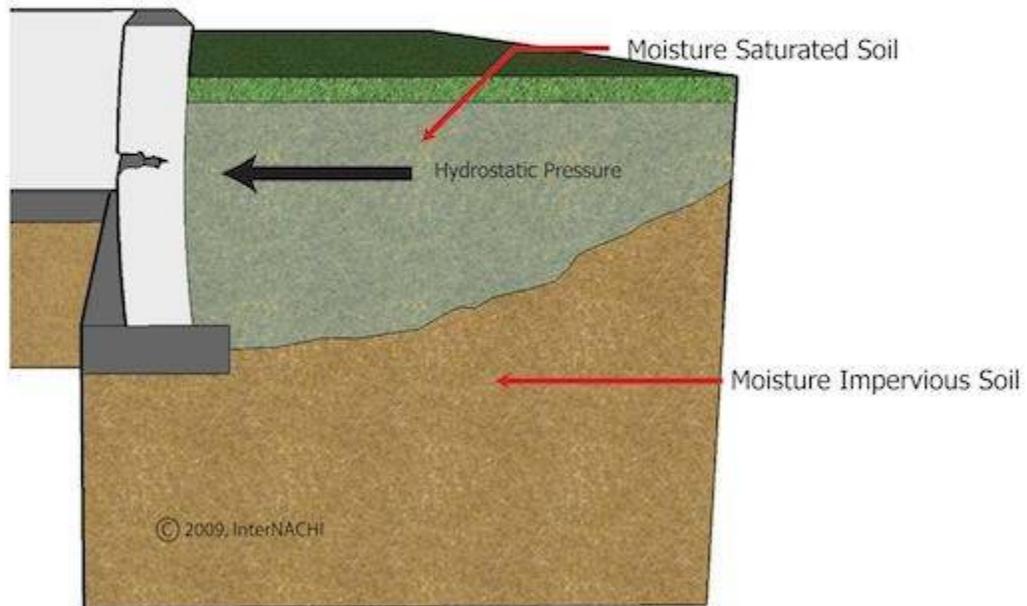
Foundation Cracks:
Lateral Movement - Side View
Horizontal Cracking

Lateral pressure resulting in a horizontal crack

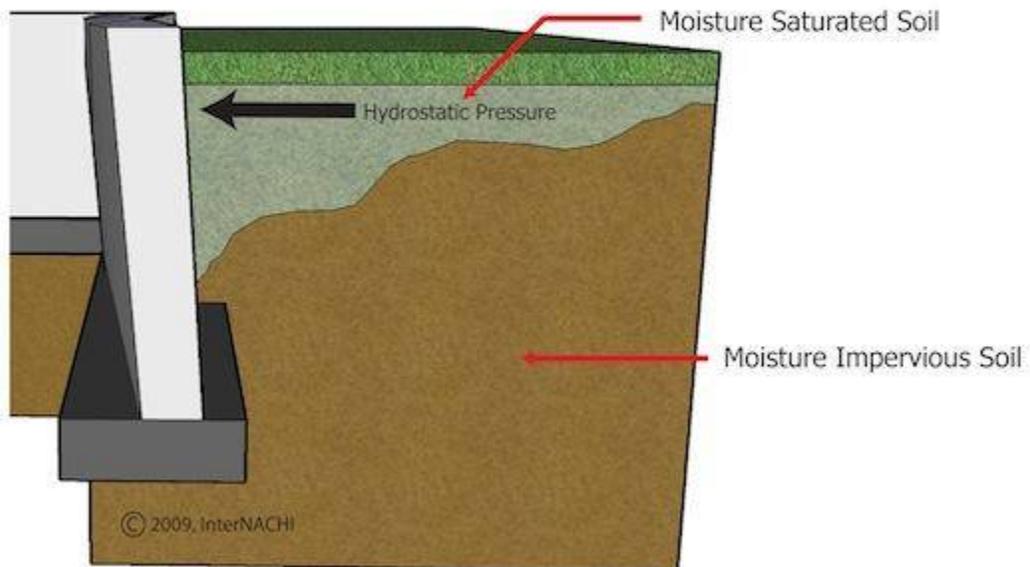
Foundation Cracks:
Lateral Movement - Side View
Vertical Cracking

Lateral pressure resulting in a vertical crack

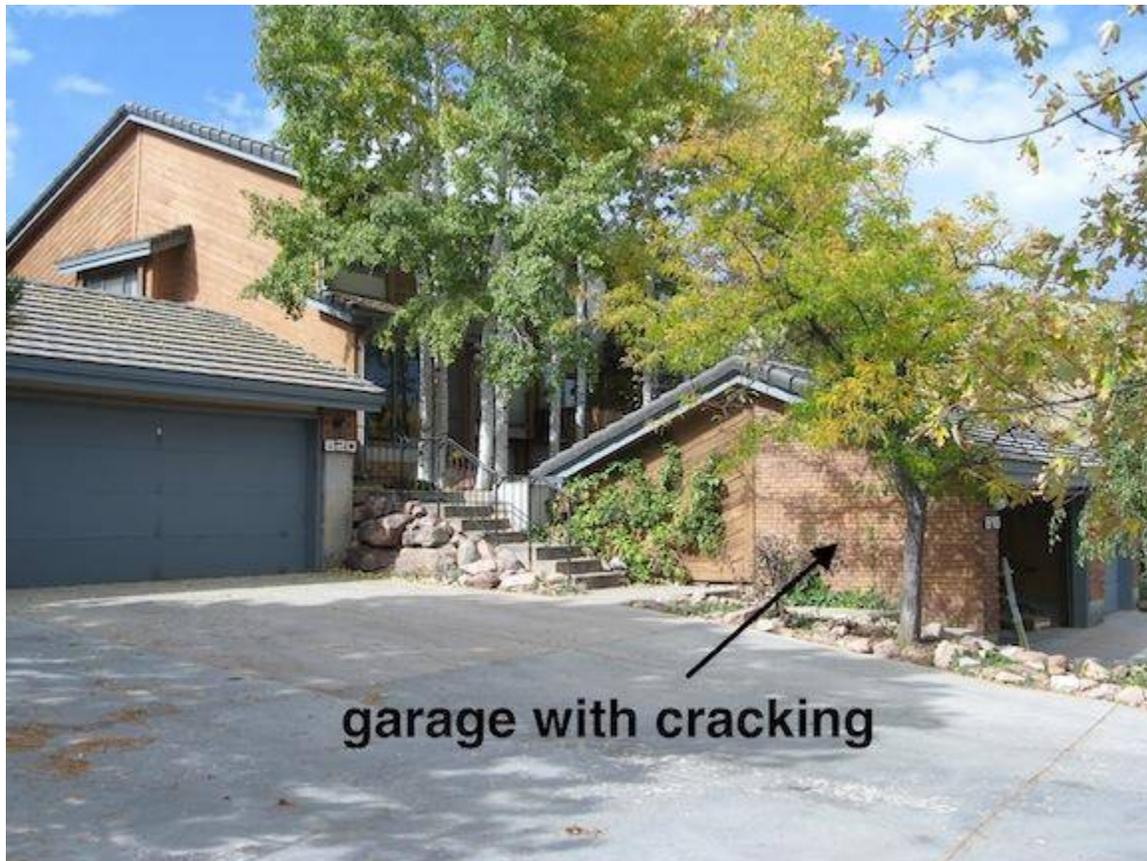
The photos below show a garage built into a hillside. Cracking along the back wall of the garage is the result of the concrete's inability to resist lateral forces from the soil. The force may have been created by machinery during the original backfill operations, or it may have resulted over time from the weight of water-saturated soil. The correction was to raise a section of the end wall to help resist rotation, and to install a steel beam as a strongback. Inspectors should not recommend specific corrections but should recommend that a structural engineer be consulted to design corrective measures.

The problem was located in the garage to the right.

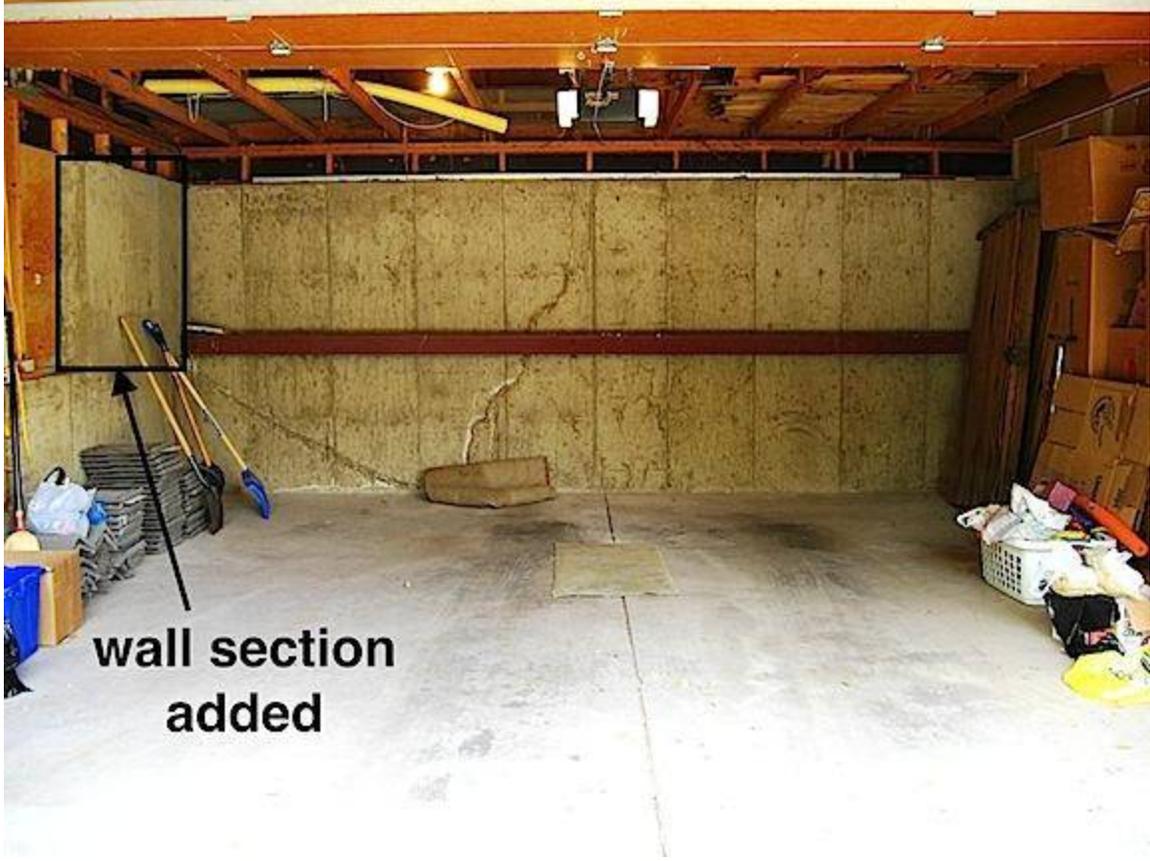
**wall section
added**

A section of the concrete foundation wall at the left was extended (the black rectangle).

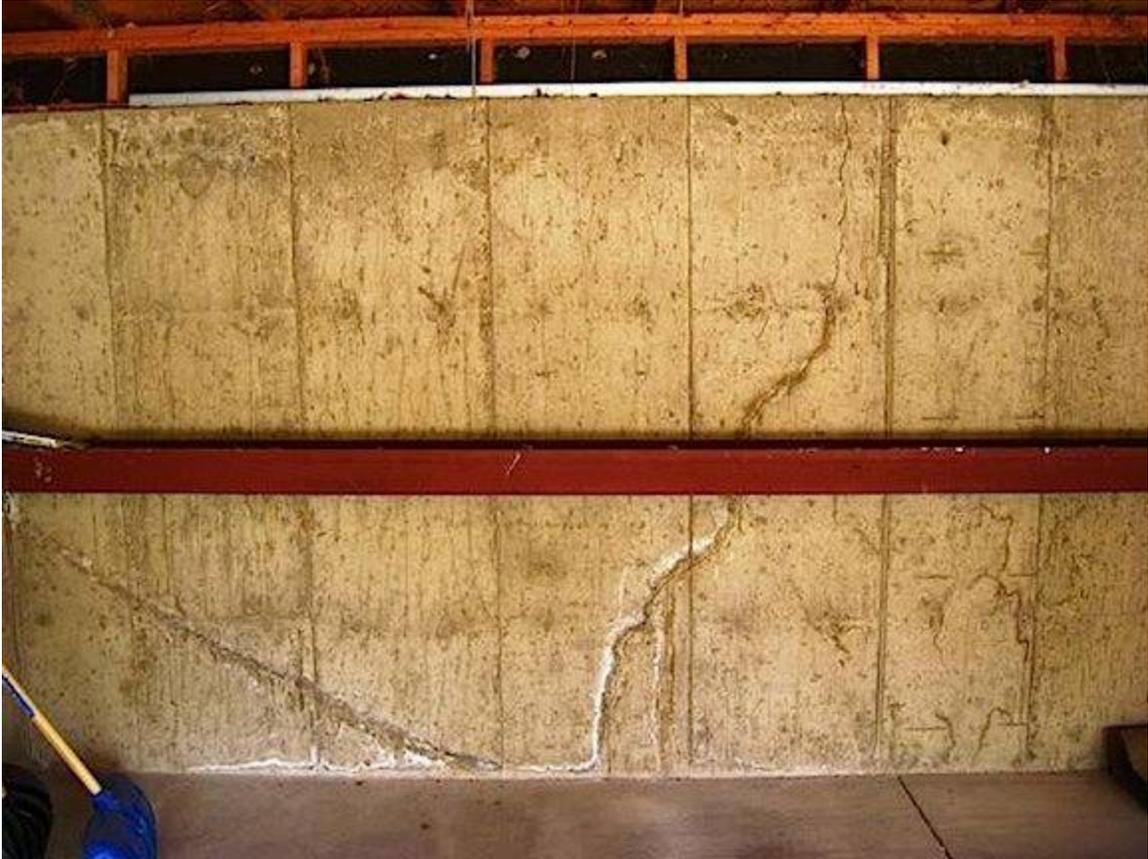
A steel I-beam acts as a strongback. (The top flange of the beam is facing the camera).
