Most information available about concrete is written for contractors, for those who design concrete mixes, and for those who perform invasive testing. The information provided here is specifically for those who perform non-invasive, visual inspections of concrete, such as home inspectors or commercial property inspectors using the [International Standards of Practice for Inspecting Commercial Properties](#).

Constituent Material Properties

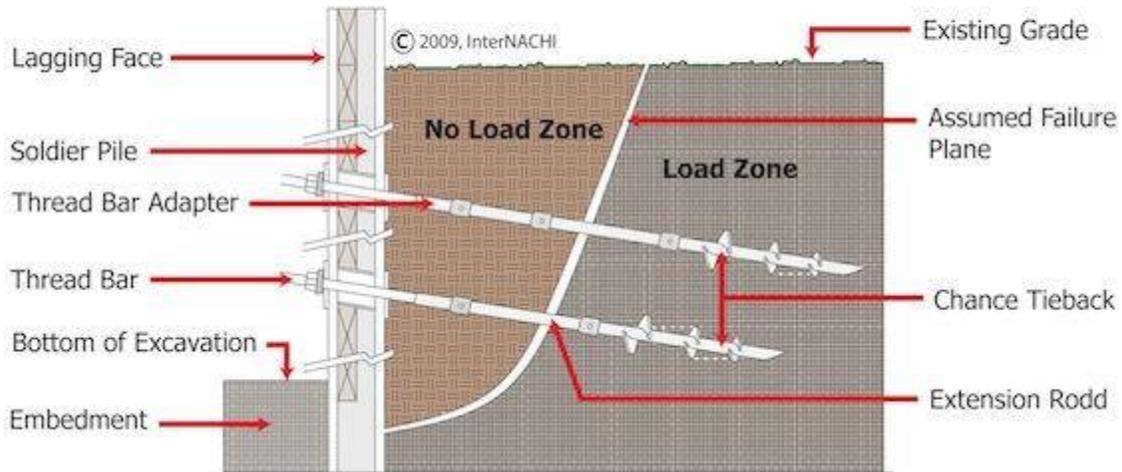
Helical Tiebacks

Helical tiebacks are used to stabilize a basement foundation wall.

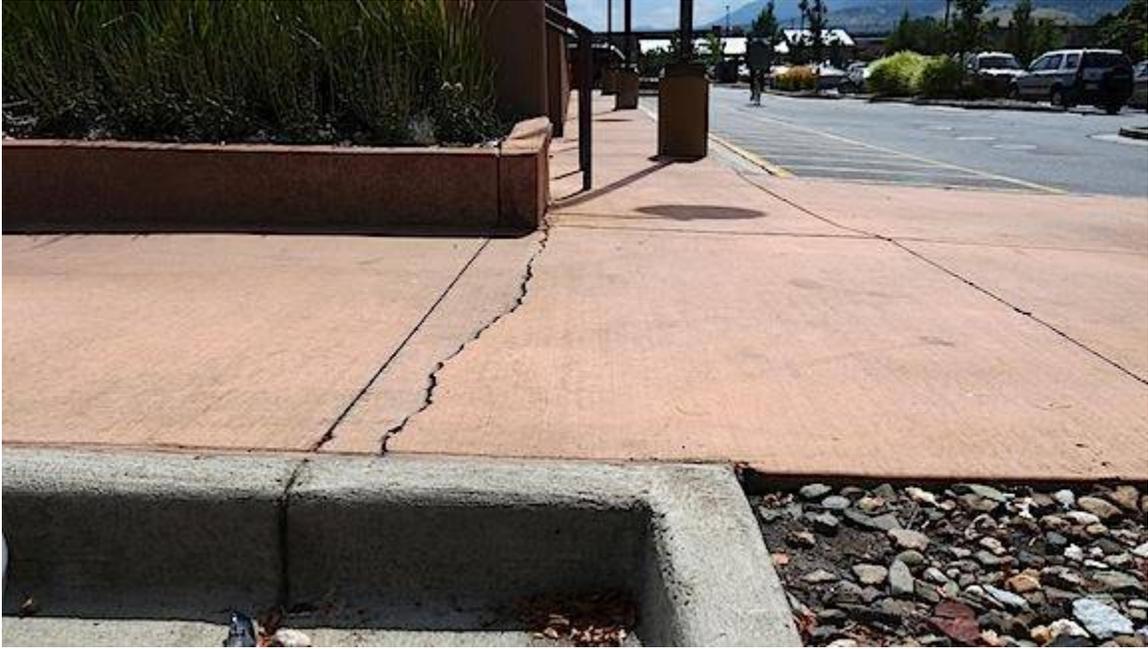
Settling caused by inadequate compaction

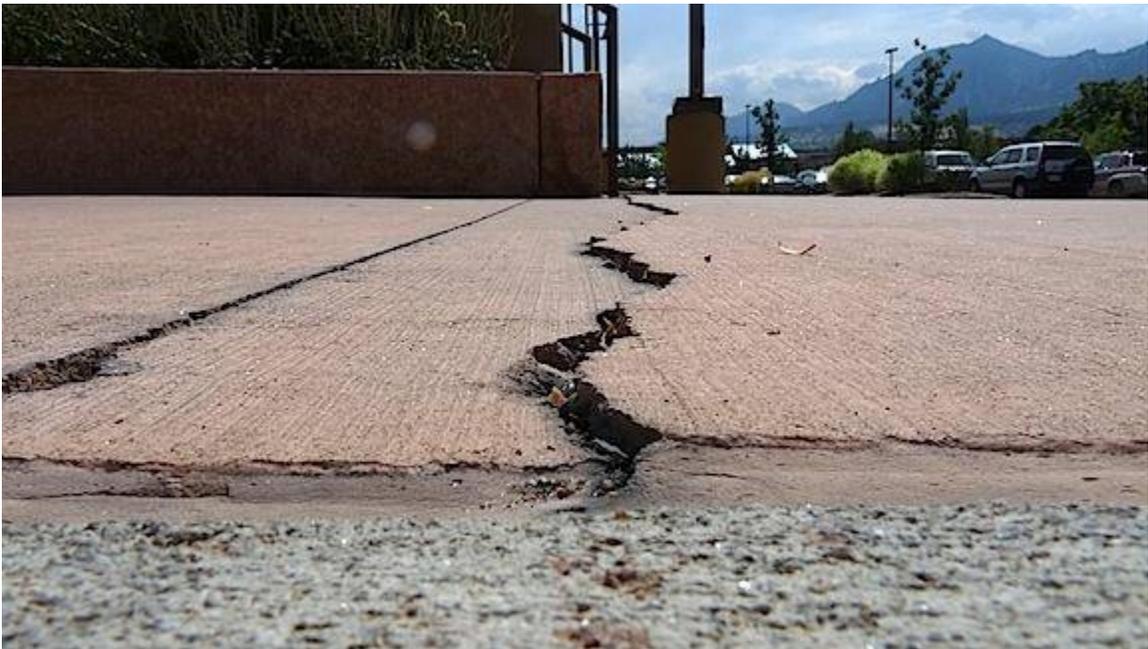
Vertical displacement occurred as the lower end of the walkway settled.

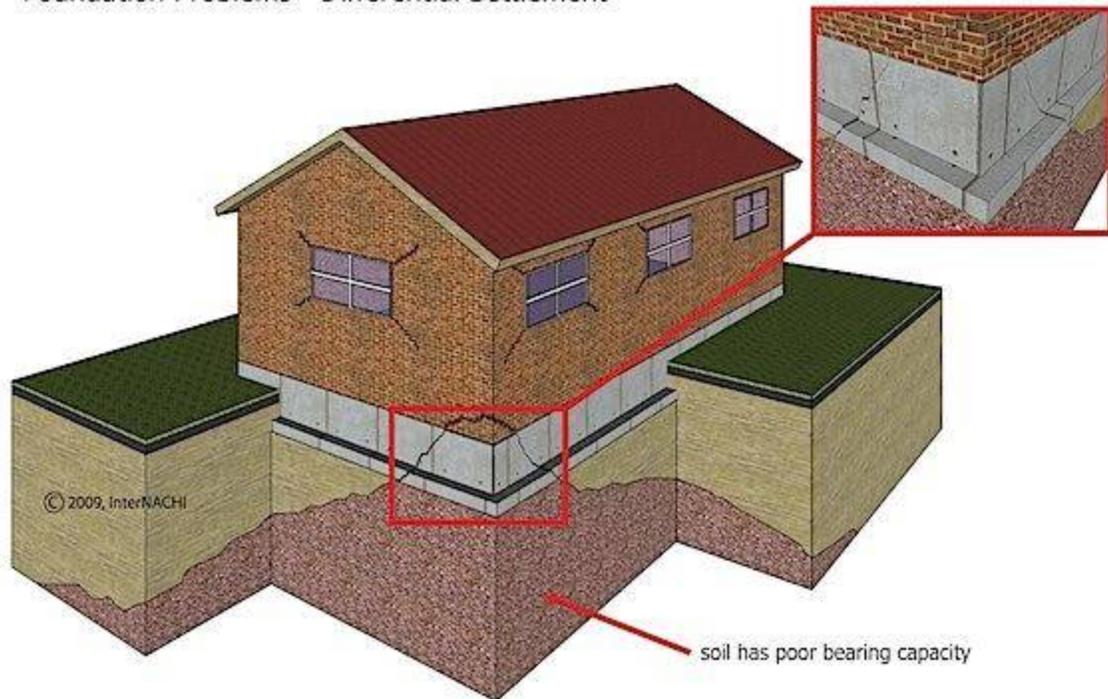
Foundation Problems - Differential Settlement

Soil with poor load-bearing capacity allows settling.

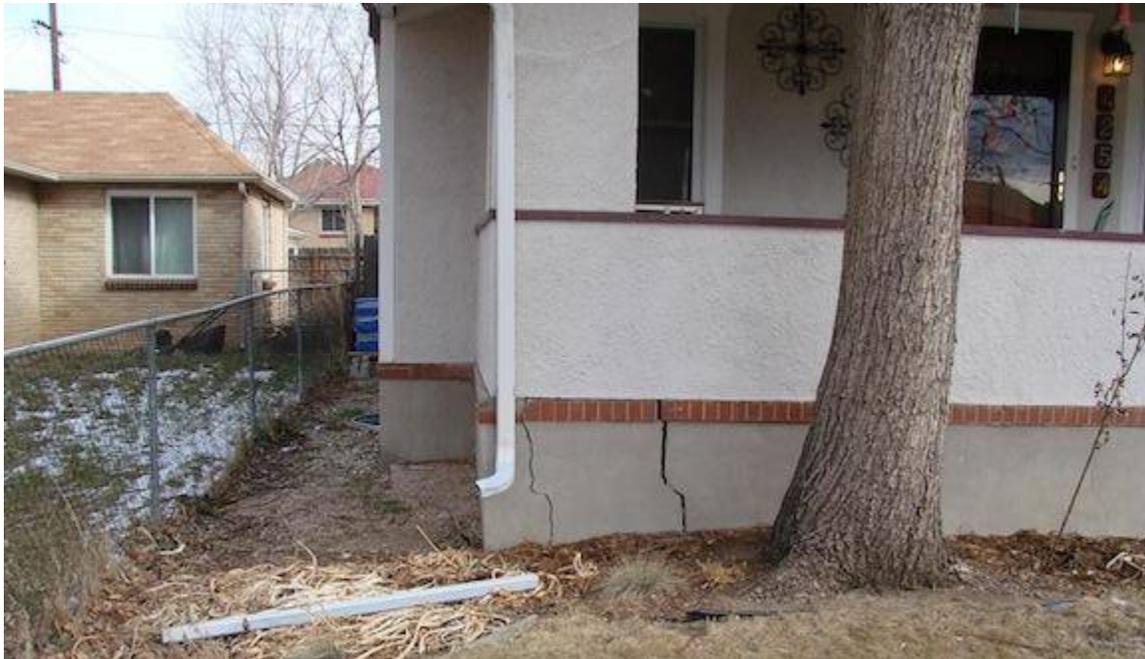
An example of differential settling

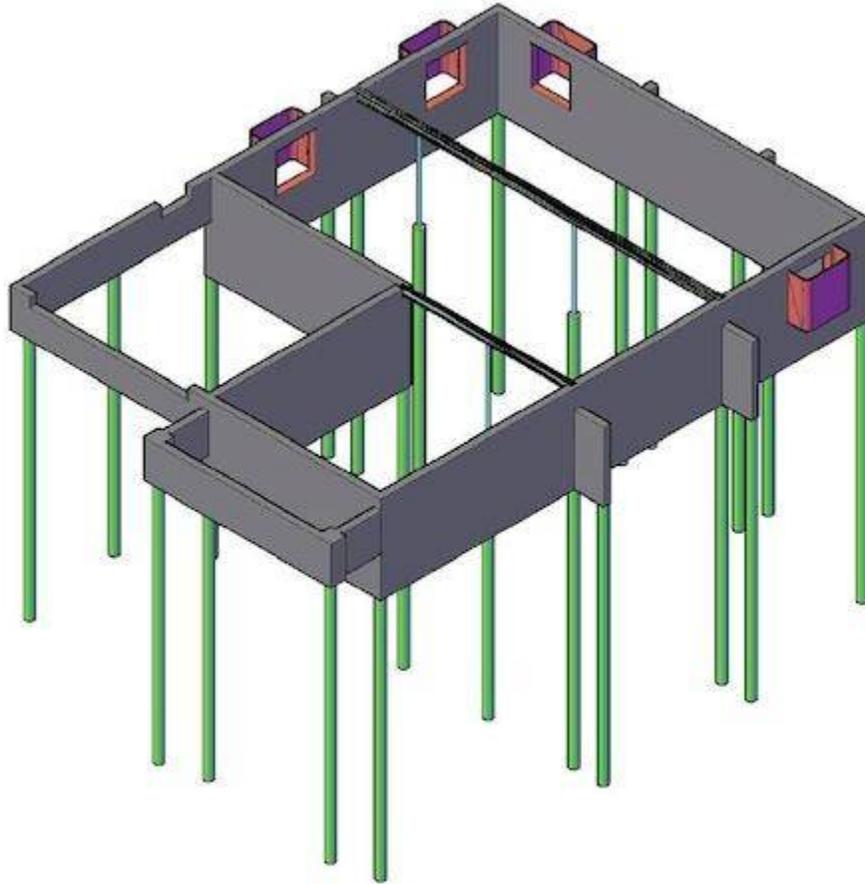
Drilled pier foundation

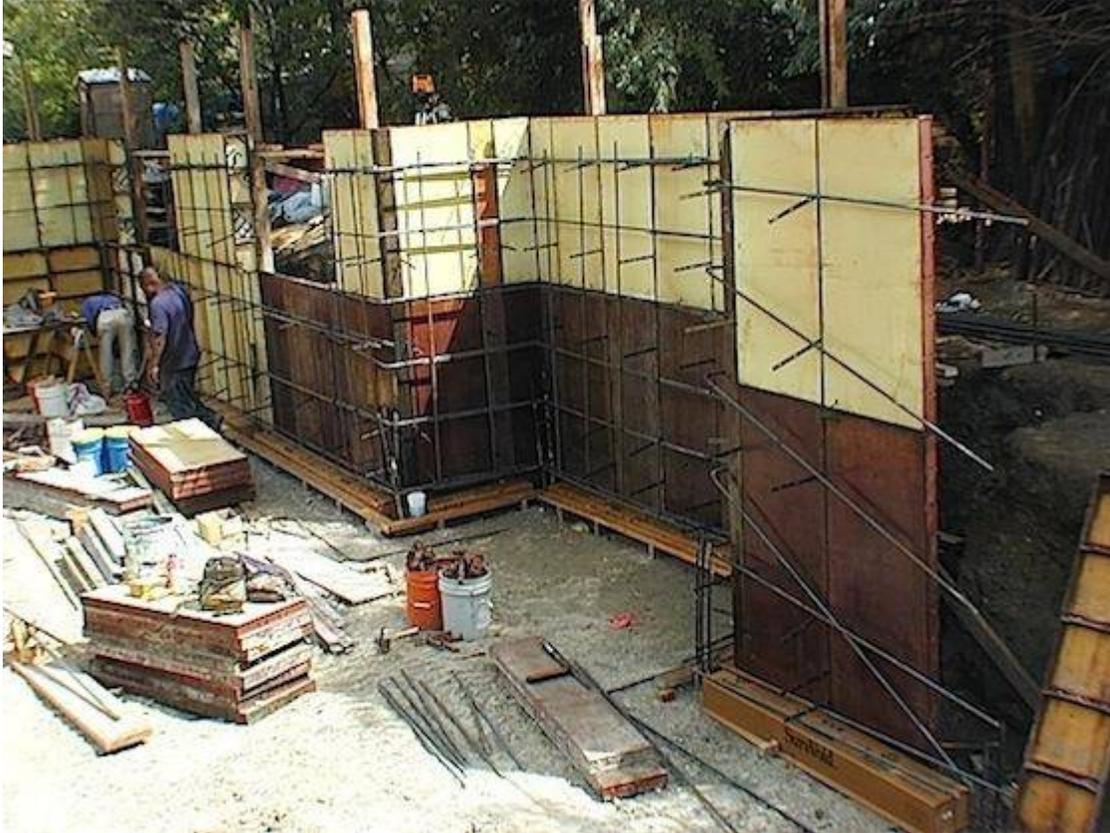
This drilled-pier foundation will be placed on void forms and piers that are resting on bedrock.

In the photo above, holes extending down to the bedrock at the corners and mid-spans of the walls will be filled with reinforced concrete to form piers. The top 3 feet of rebar are visibly protruding from the holes. Cardboard void forms placed on the ground between the piers and inside the forms are strong enough to bear the weight of the concrete when it is poured, creating voids beneath the walls. If the soil heaves, the void forms will be crushed. The amount of heaving will have to be greater than the thickness of the void forms (typically, 6 inches) for the soil to come into contact with the bottom of the foundation walls. Inspectors may be able to verify that a drilled-pier foundation has been installed but they will not be able to confirm the depth to which the piers were drilled, so they should observe carefully for signs of foundation movement.

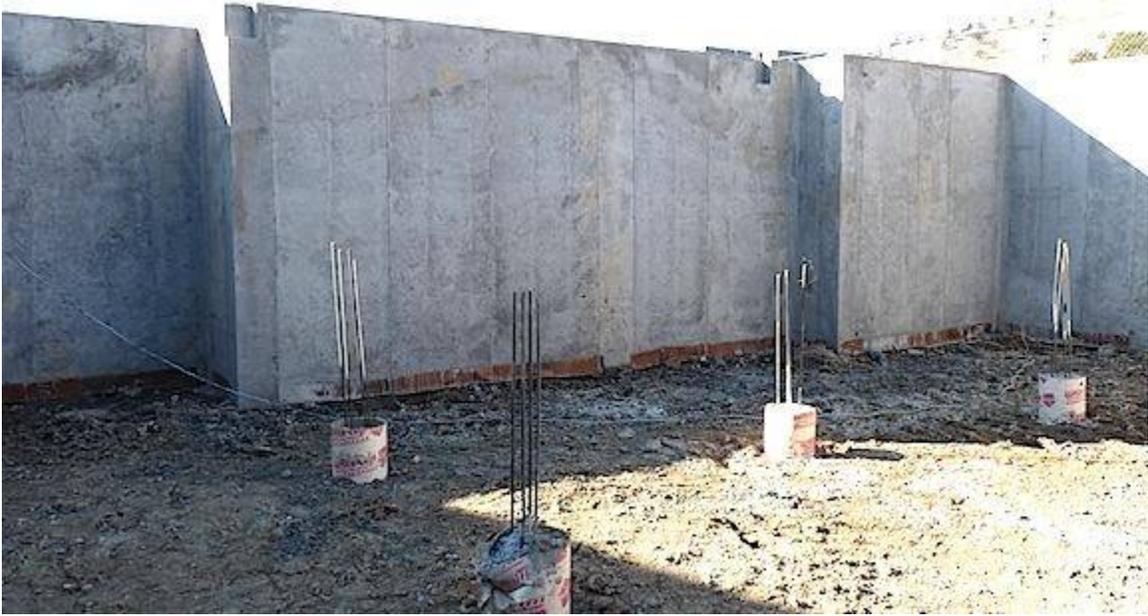
Void forms after the walls have been poured

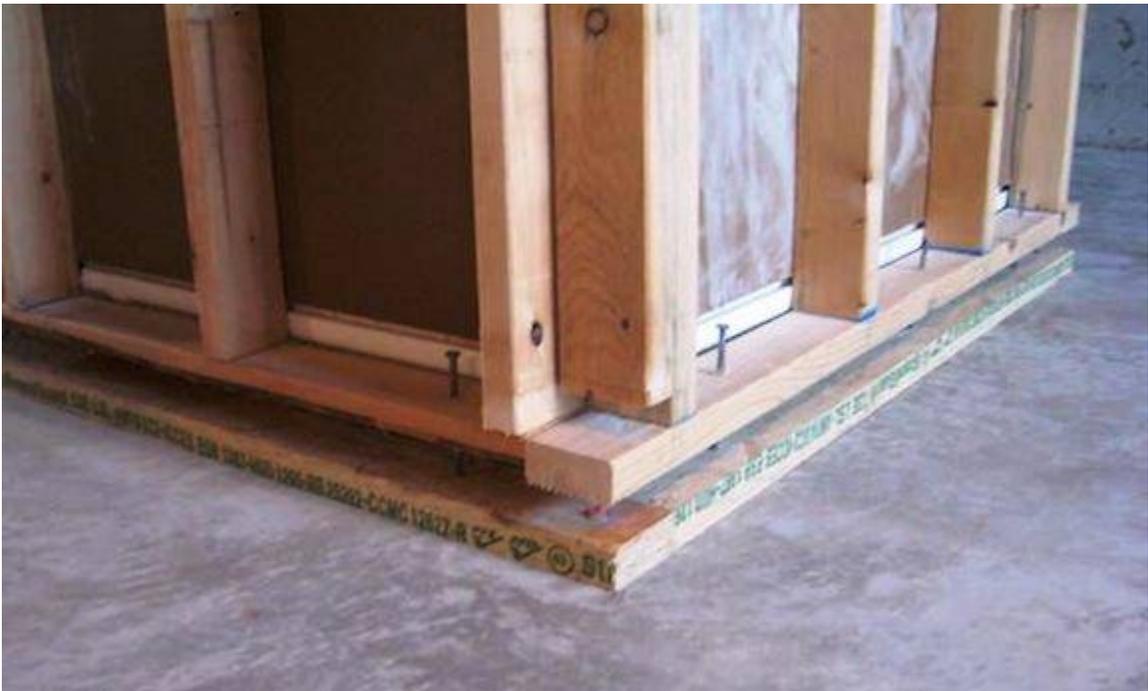
The doubled bottom plate accommodates heaving.

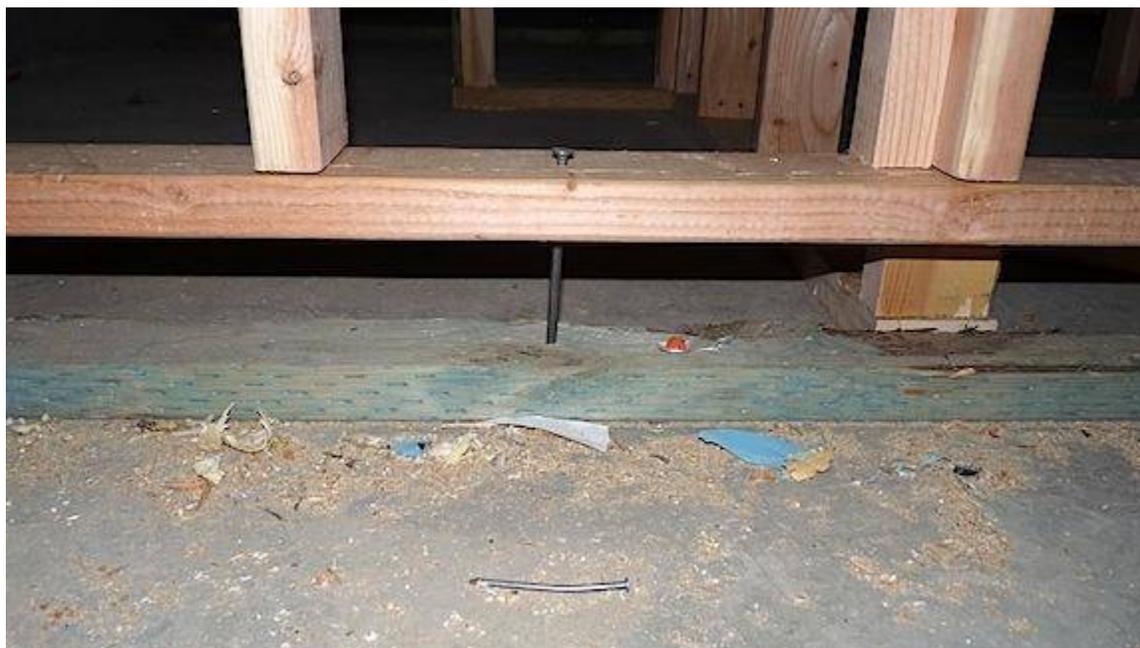
A doubled bottom plate connected to a wall with a single bottom plate

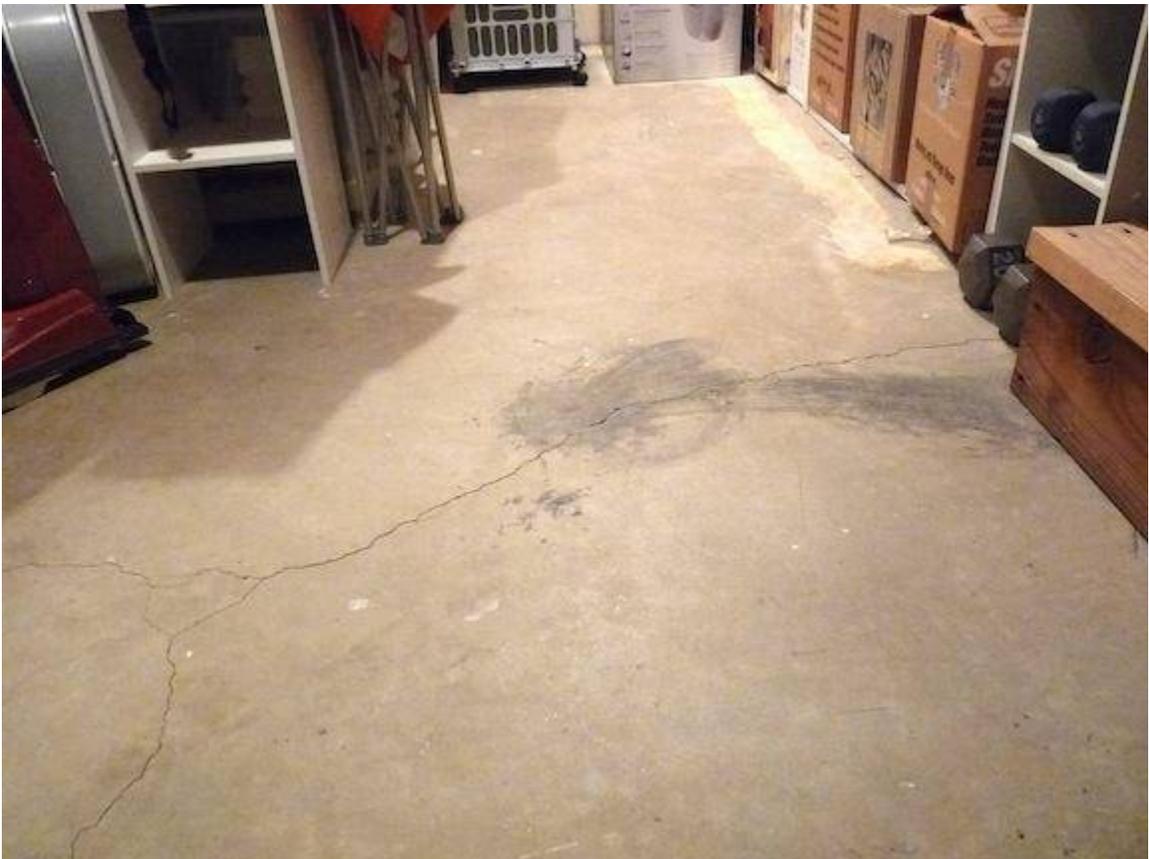
This cracking was caused by expansive soil.

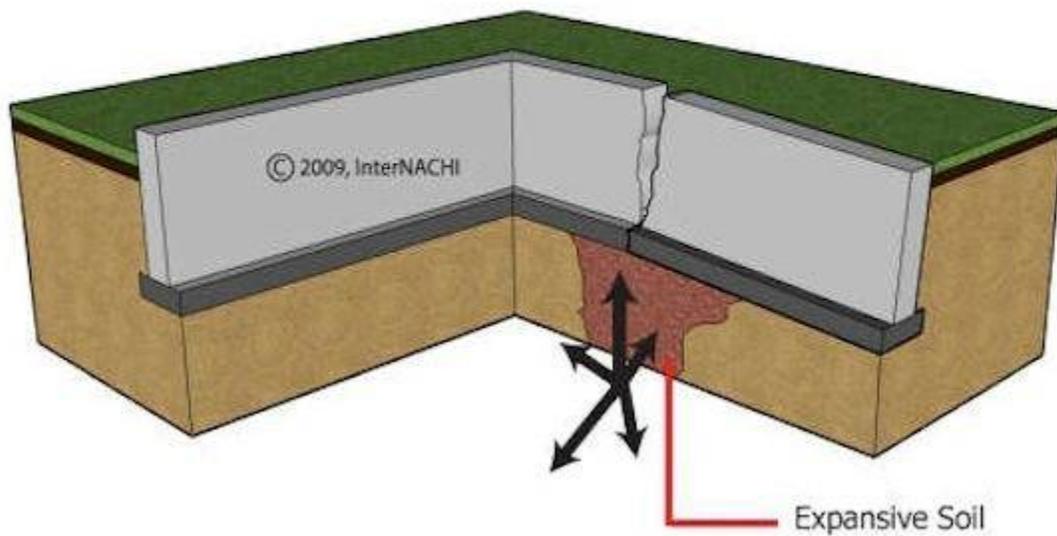
Foundation Cracks: Heaving

Crack caused by heaving

Cracks caused by heaving may be wider at the top, as shown in the illustration above, but this condition can also be caused by settling toward one corner.

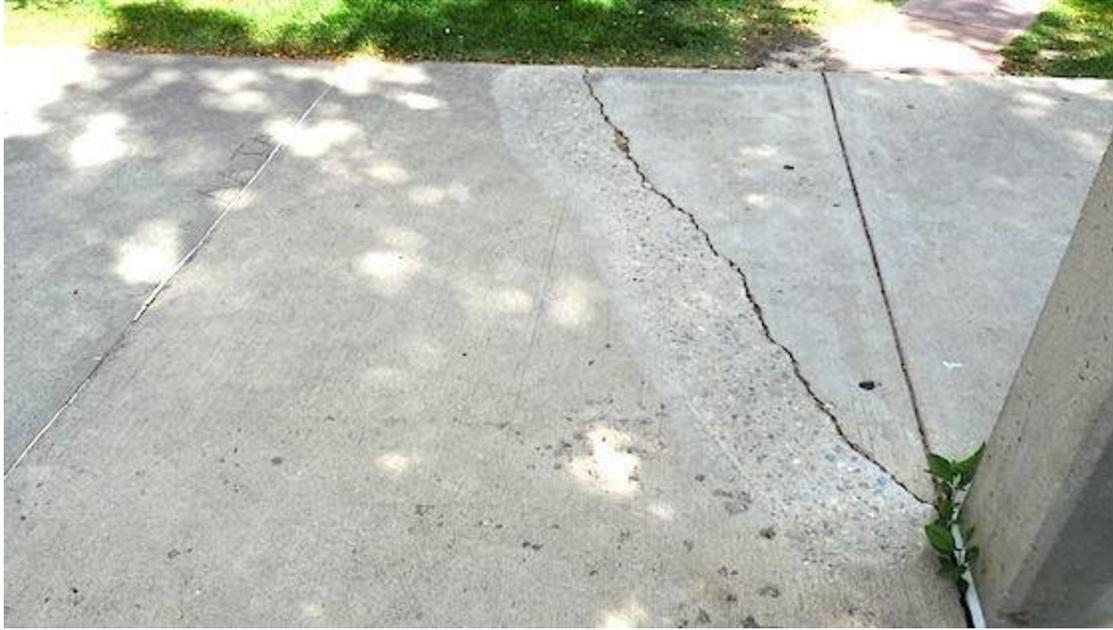
Vertical displacement creates trip hazards and you may see concrete ground down to alleviate this problem, as in the photo above. Inspectors who observe these types of trip hazards should recommend correction. In areas with expansive soils, inspectors need to be diligent in identifying negative and neutral grade around the foundation and recommending mitigation. Typical mitigation involves correcting the grade and/or installing a plastic membrane beneath the topsoil around the home's perimeter to act as a barrier to runoff seeping down next to the foundation.

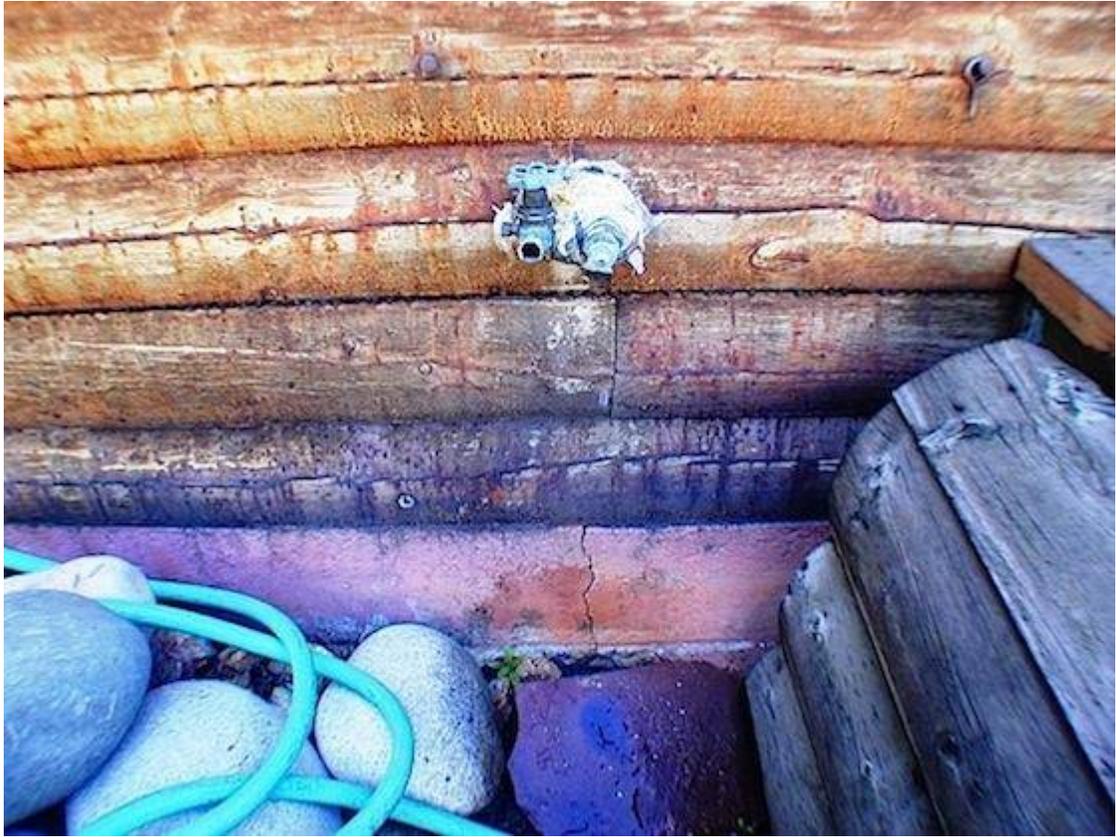
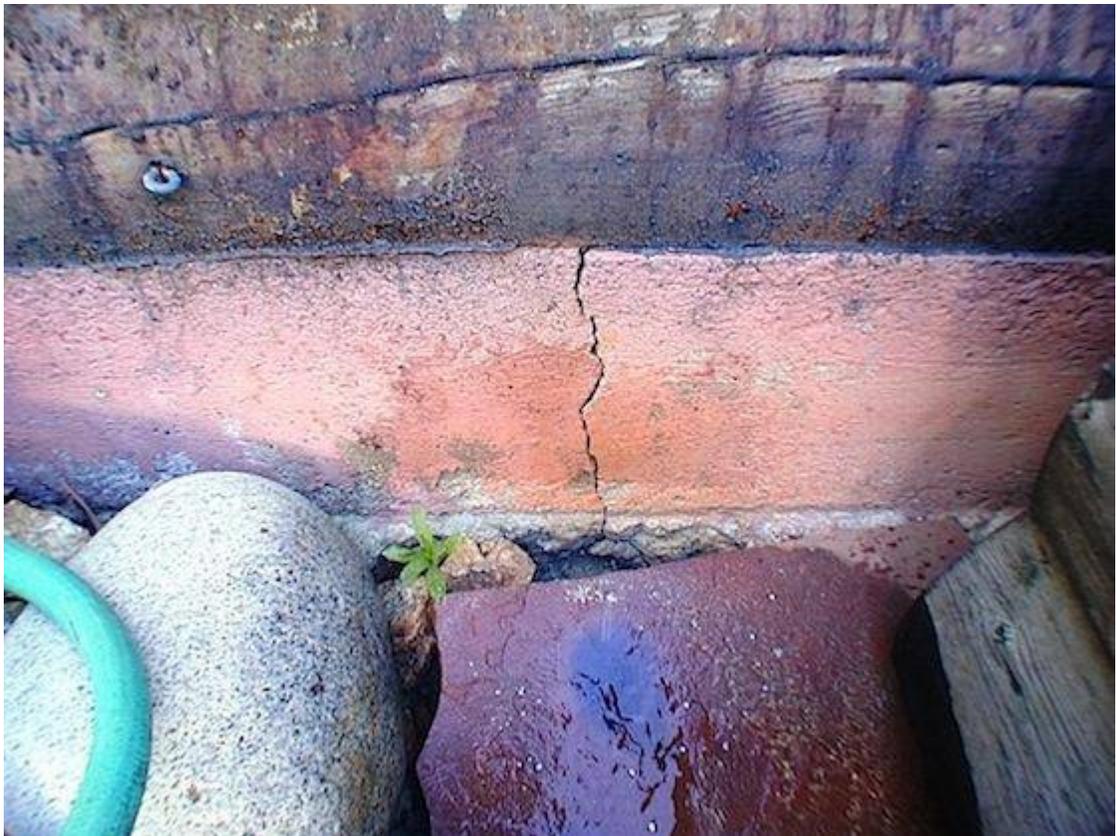
The photos above show a foundation crack that was caused by soil that was saturated by a leaking hose bib. When the water in the soil froze, it expanded, cracking the foundation. Notice that the crack is wider at the top.

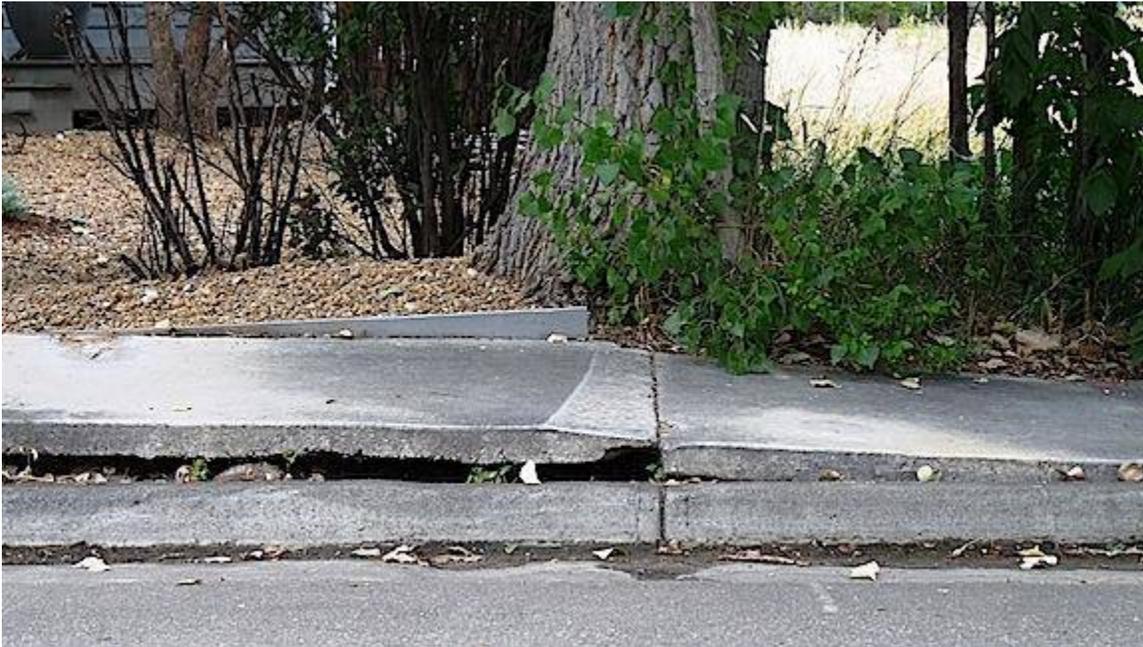
Tree roots may also cause concrete to heave. As shown in the photo below, it was less expensive to grind off the protruding portion than to demolish and replace the walkway.

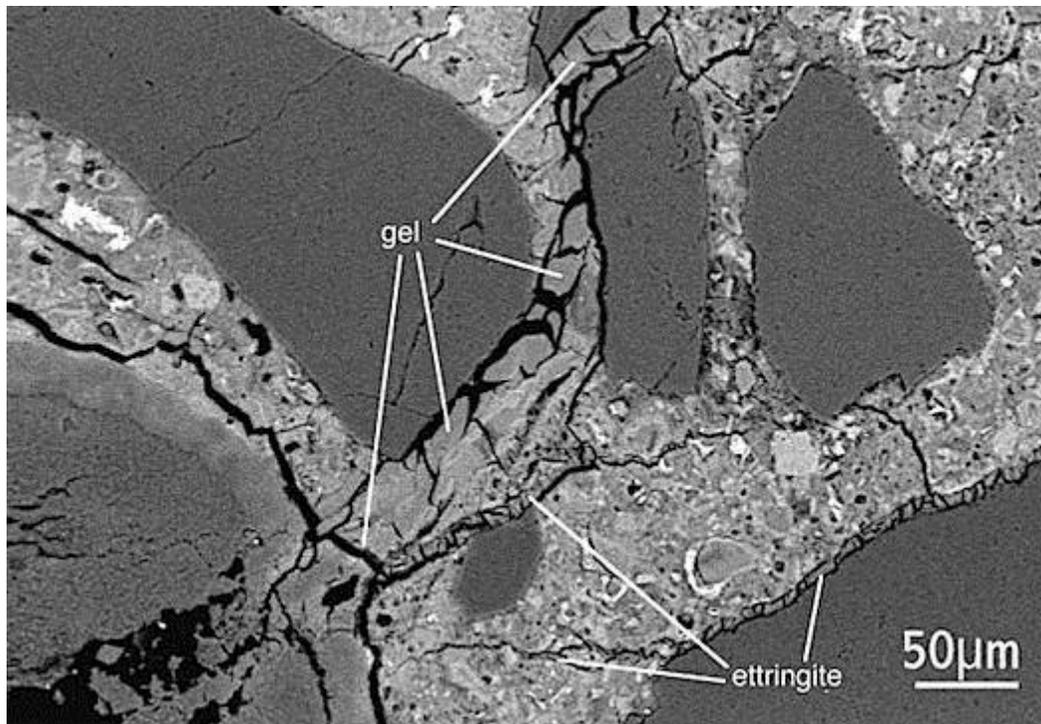
This photo, taken through a microscope, shows gel formation between fine aggregate particles. If water should reach this gel through pores or cracks, it will expand, cracking the concrete.

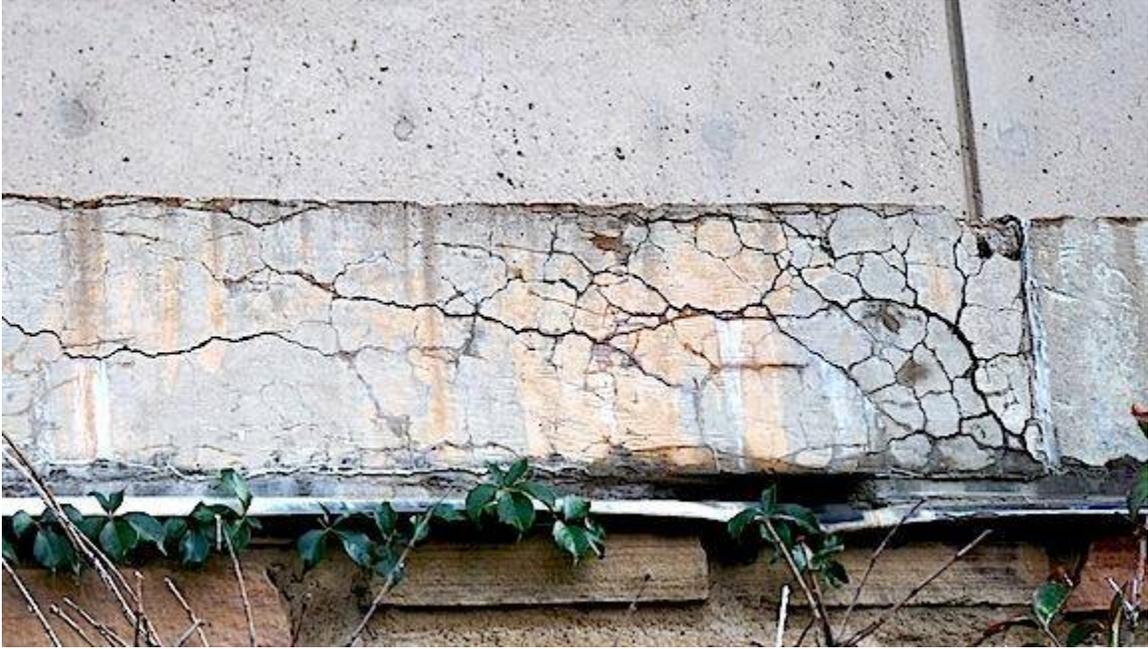
This condition may be caused by ASR, but only laboratory testing can confirm this. Inspectors do not need to identify the source of the condition – only its severity. The recommendation here would be to consult with a concrete contractor to gain an understanding of options and cost for replacement.

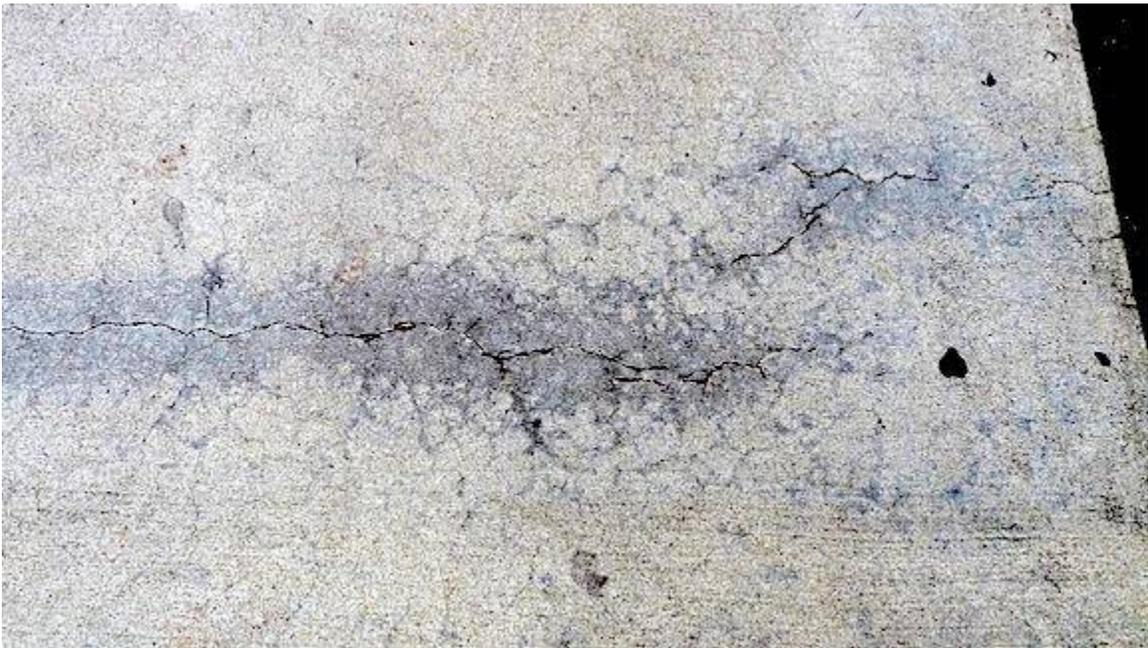
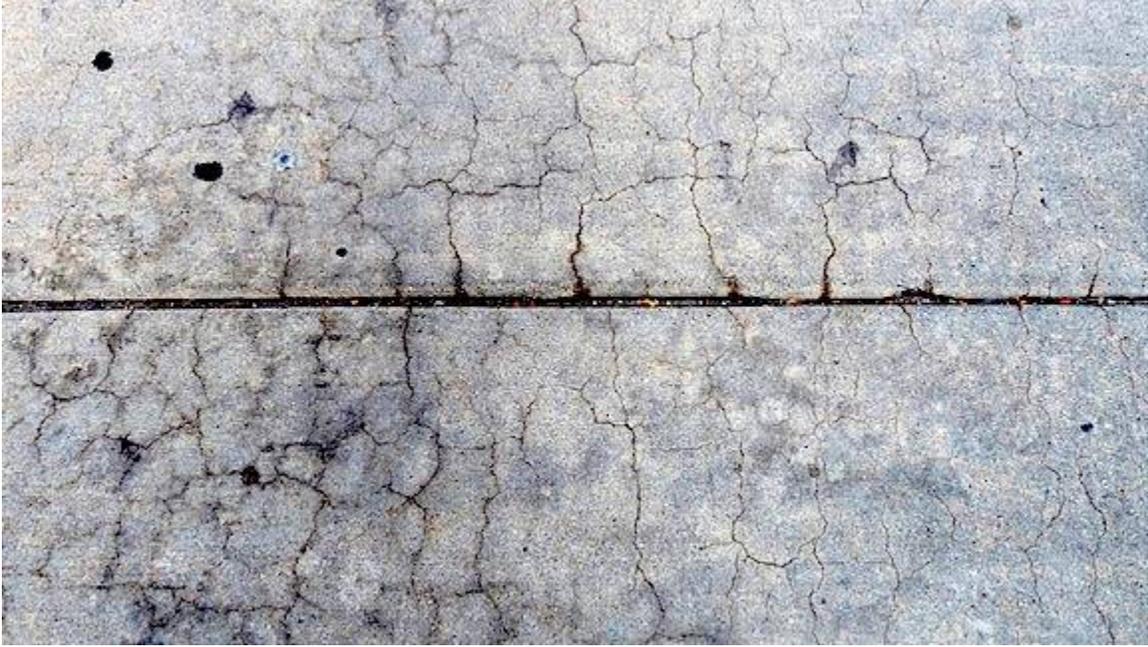
The two photos below show concrete of approximately the same age containing aggregate that reacts differently to moisture. Cracking and discoloration along the control joint, shown in the lower photo, is more severe and the concrete will deteriorate more quickly than that shown in the upper photo .

Although this cracking looks similar to pattern cracking, the fact that it graduates in intensity, starting at the control joint, indicates that absorption from moisture accumulating in the control joint is the cause. Pattern cracking would be fairly uniform across the surface.

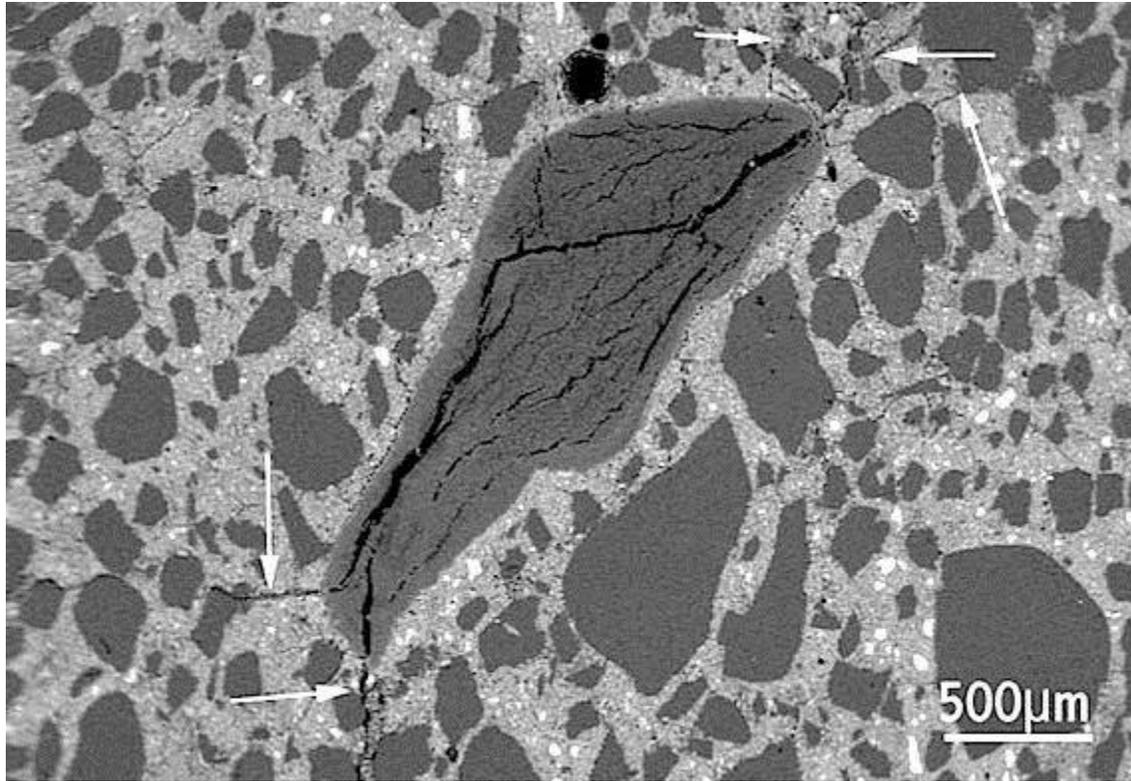
*This photo shows cracks emanating from the aggregate.
Under a load, especially a cyclic load, these cracks can grow, weakening the concrete.*

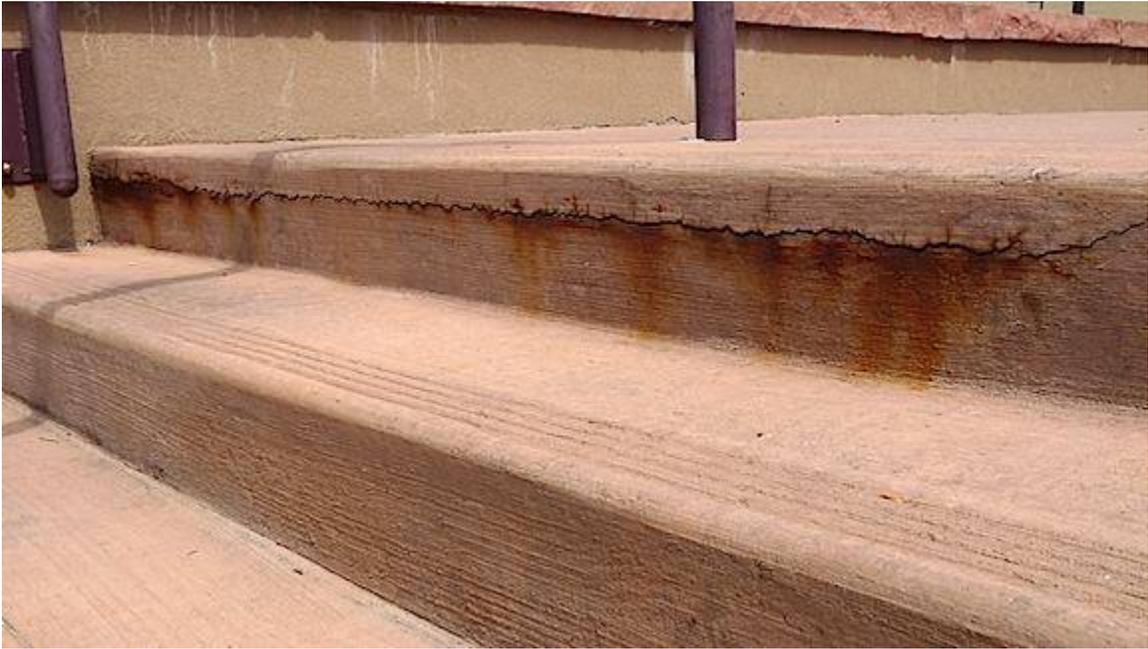
Corrosion typical of inadequate cover

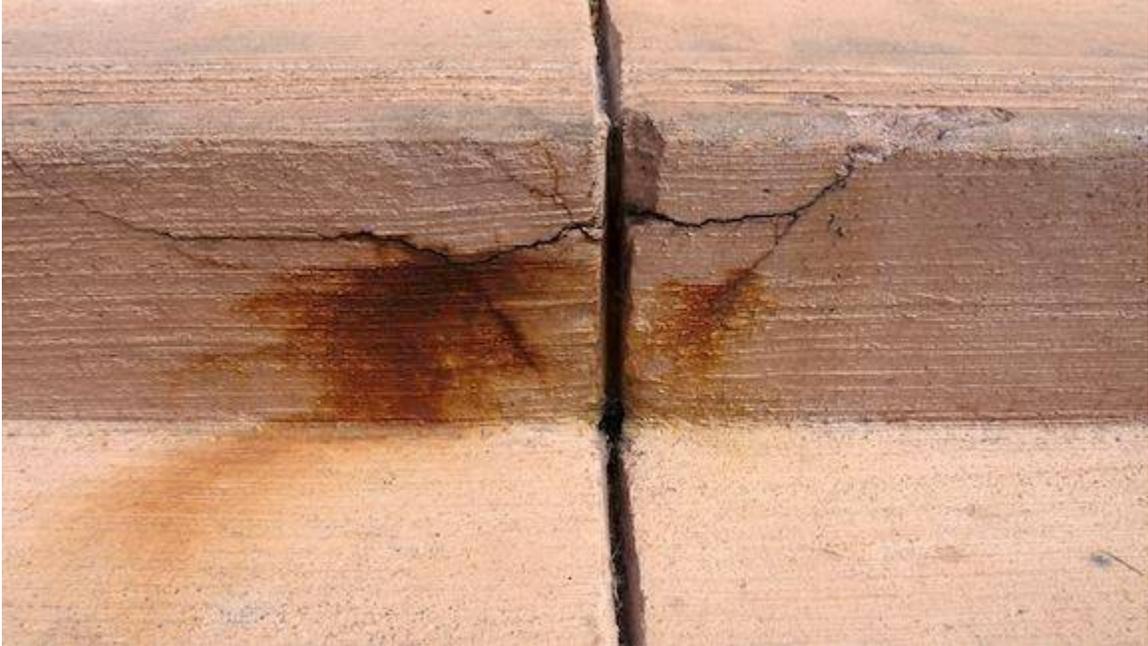
Concrete cover will be thinner at control joints.

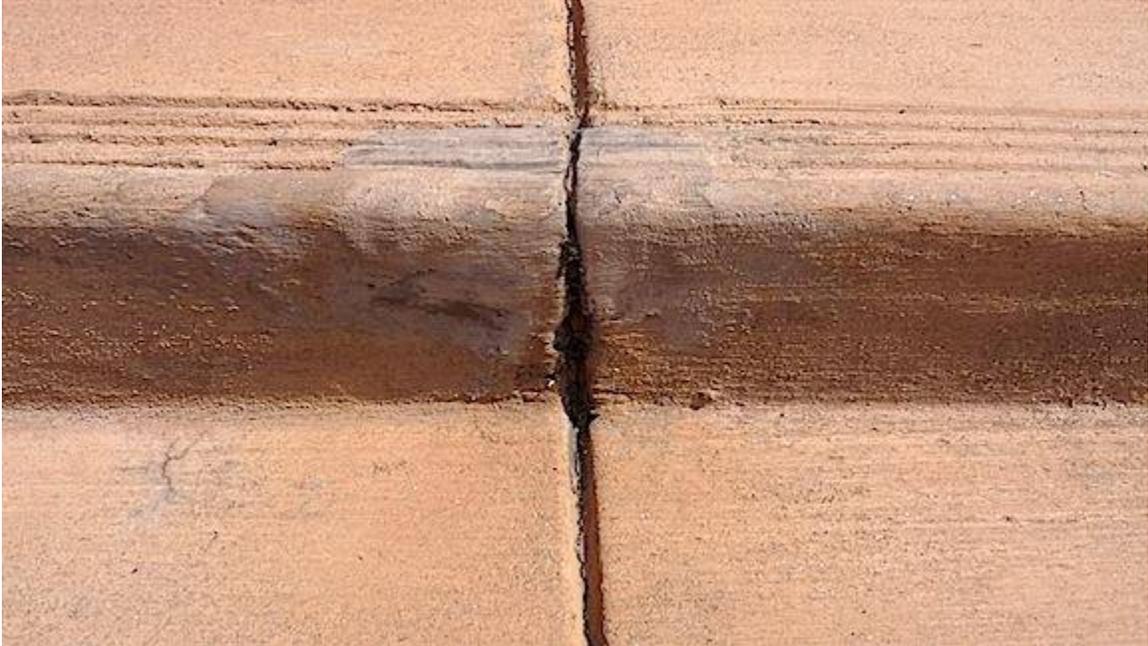
Repairs are common at control joints in stairs at well-maintained properties.

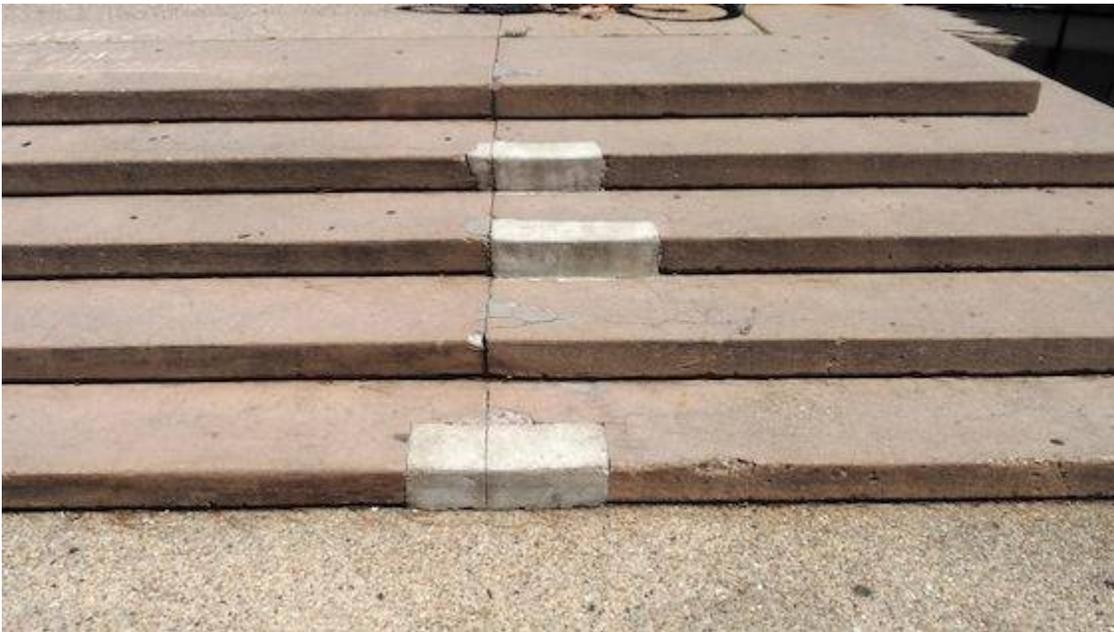
Poor-quality repairs may result in the re-appearance of corrosion.

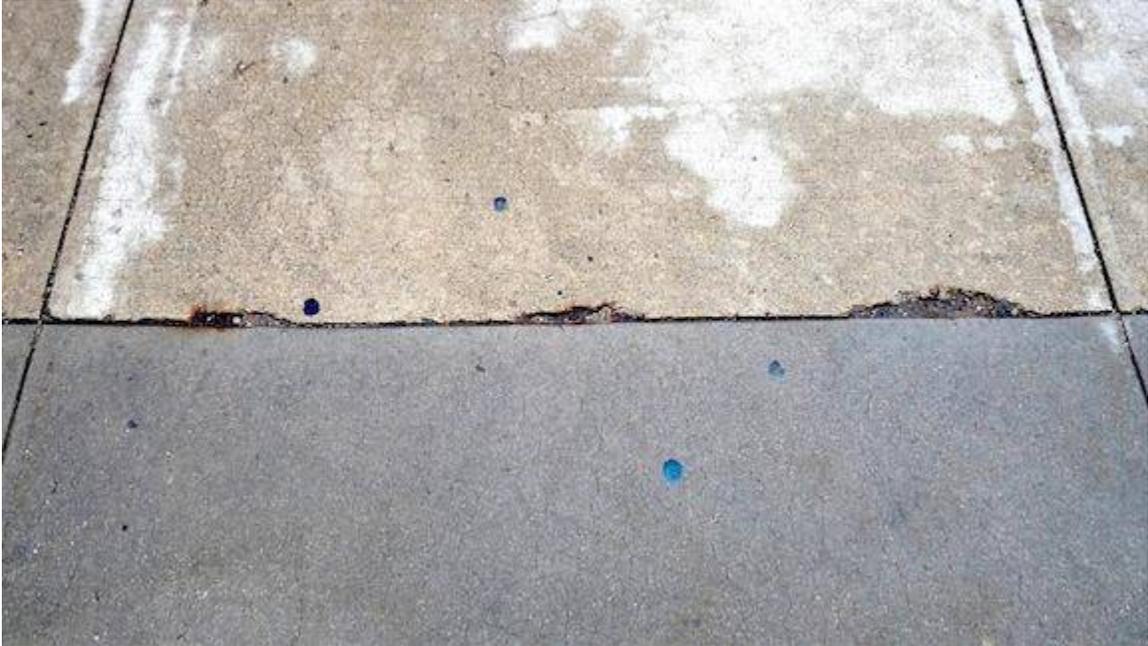
Inadequate cover due to control joints is also common in flatwork. Where control joints are installed perpendicular to embedded rebar, the areas at which the control joint crosses each bar may develop cracking and corrosion, and eventually spalling or flaking. This common condition is called D-cracking and is shown in the photo below.

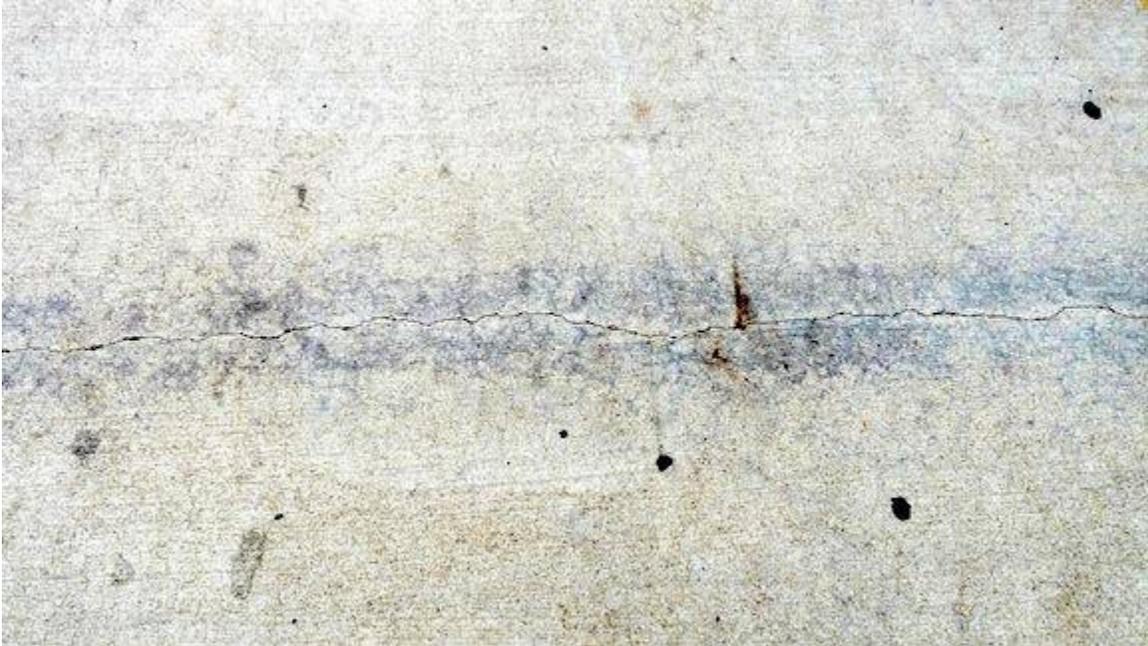
Plastic settling can cause cracking above steel reinforcement that can allow corrosive agents, such as water and chloride solutions, to reach and corrode steel. Cracks resulting from plastic settlement do not always cause corrosion. If reinforcement steel has adequate coverage, corrosive agents will not reach it. A closer look (below) shows discoloration that has developed along the resulting settlement crack.

If discoloration above a settling crack were caused by corroding rebar, it would be rust-colored. The discoloration in the photo above is most likely caused by reactive aggregate. Discoloration will spread and cracking will worsen slowly.

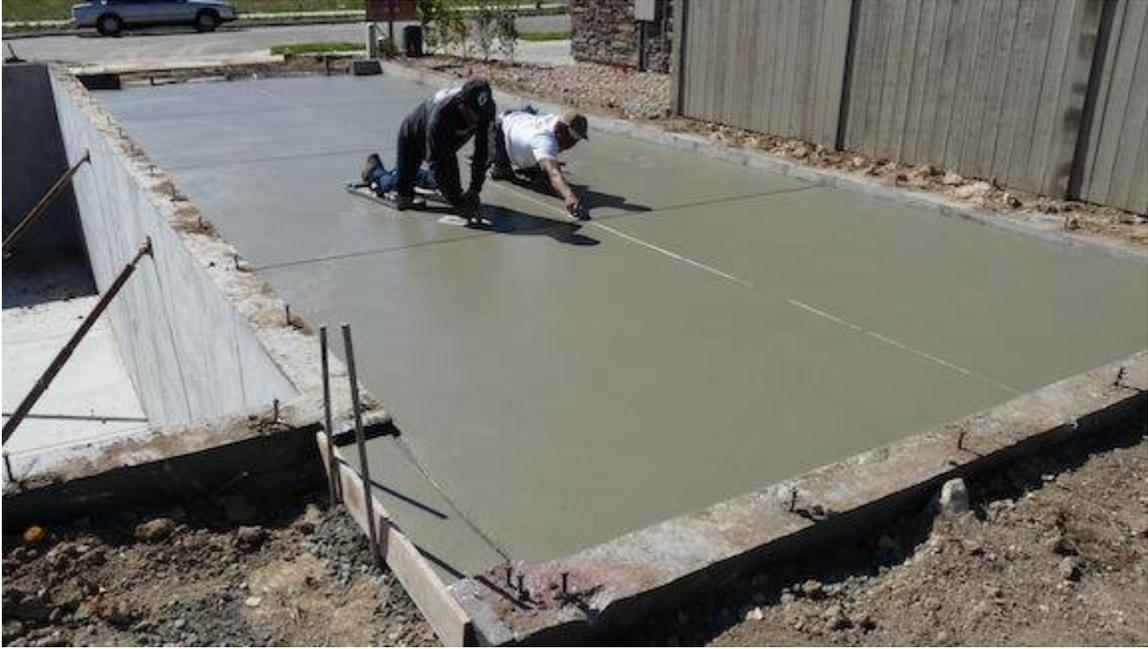
The new floor, which will expand, is contained by the foundation wall.
