Most information available about concrete is written for contractors, for those who design concrete mixes, and for those who perform invasive testing. The information provided here is specifically for those who perform non-invasive, visual inspections of concrete, such as home inspectors or commercial property inspectors using the [International Standards of Practice for Inspecting Commercial Properties](#).

Constituent Material Properties

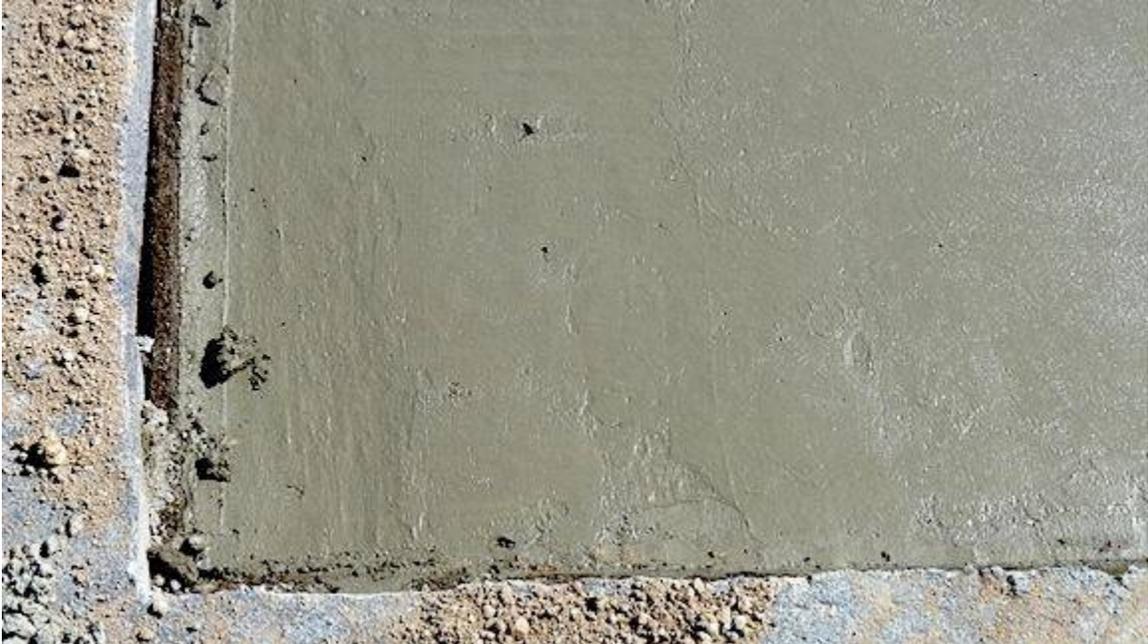
Fibrous isolation-joint material allows the slab to expand without damaging the foundation wall.

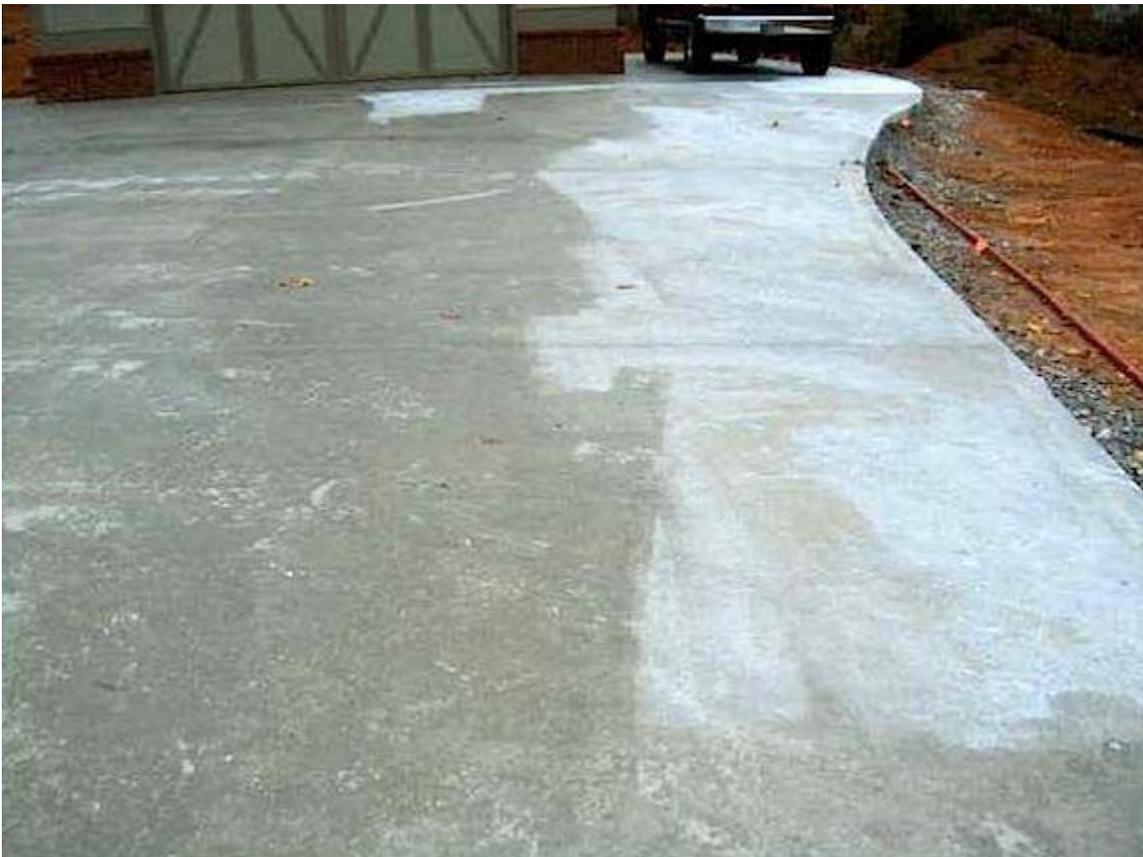
Sealer applied over an excessively wet surface

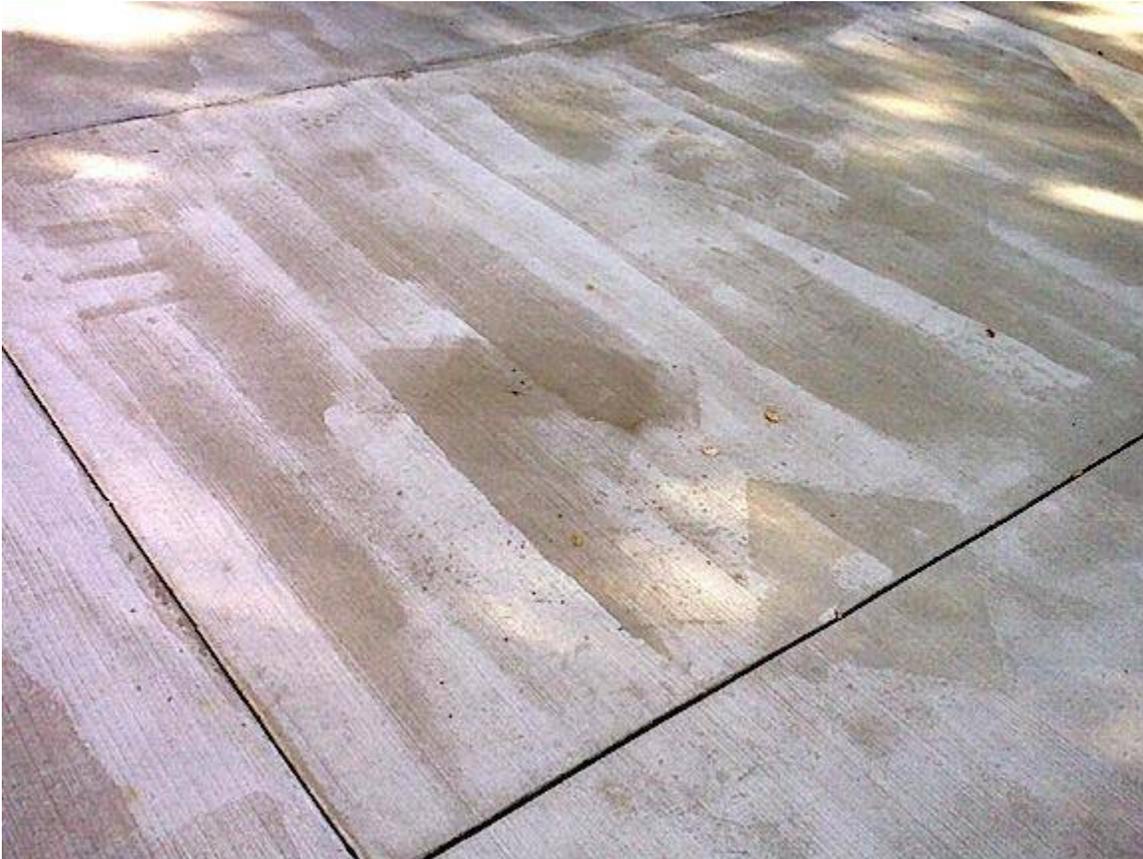
Improper sealer application with a roller

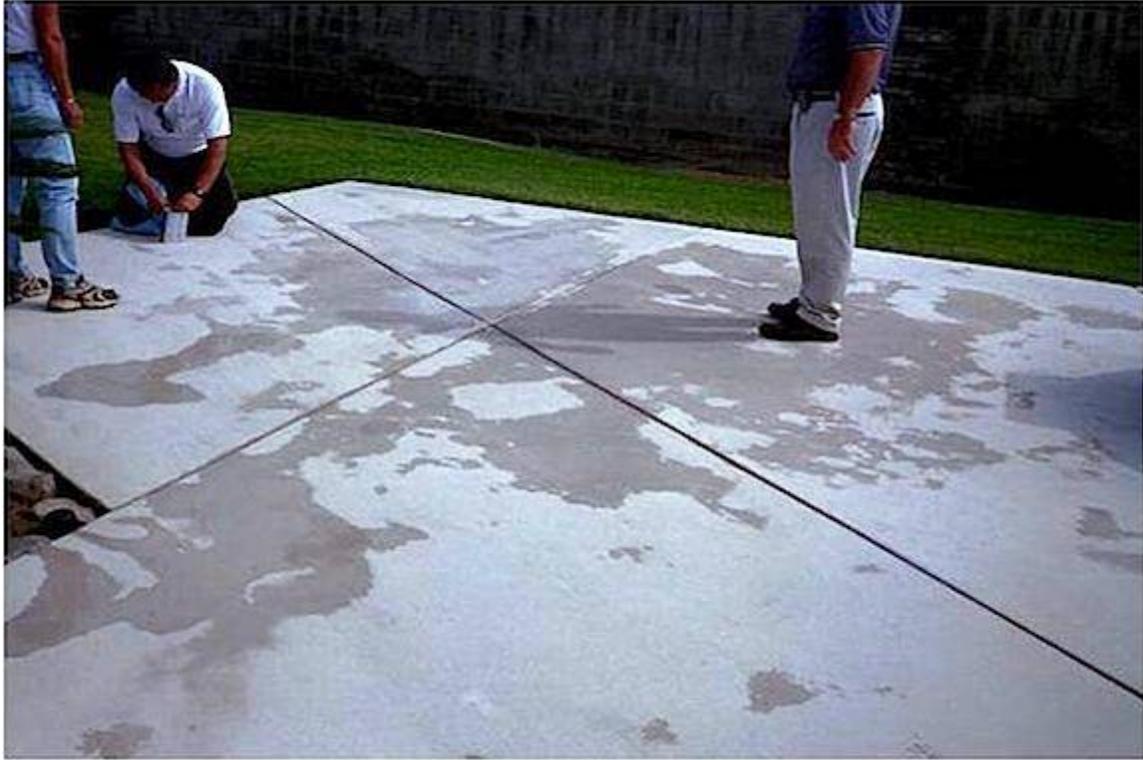
Poor sub-base preparation

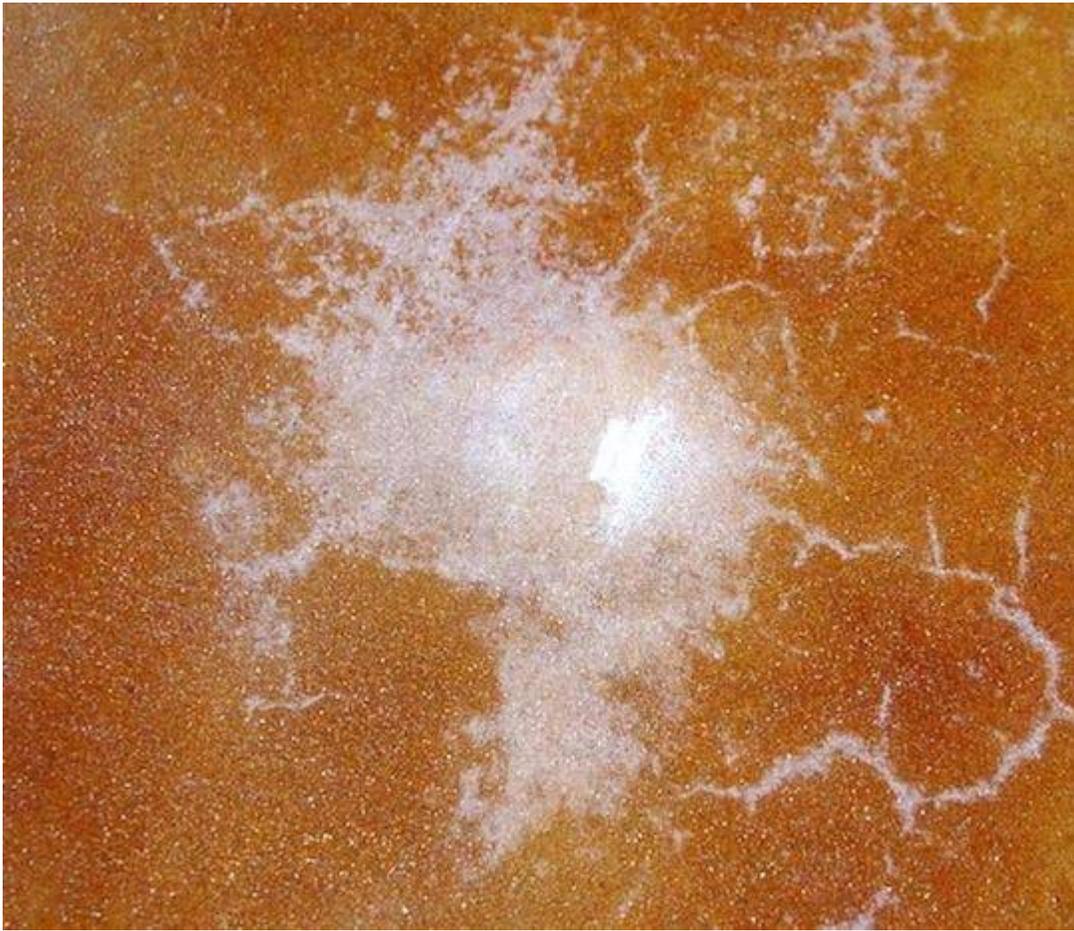
Improper sealer film formation

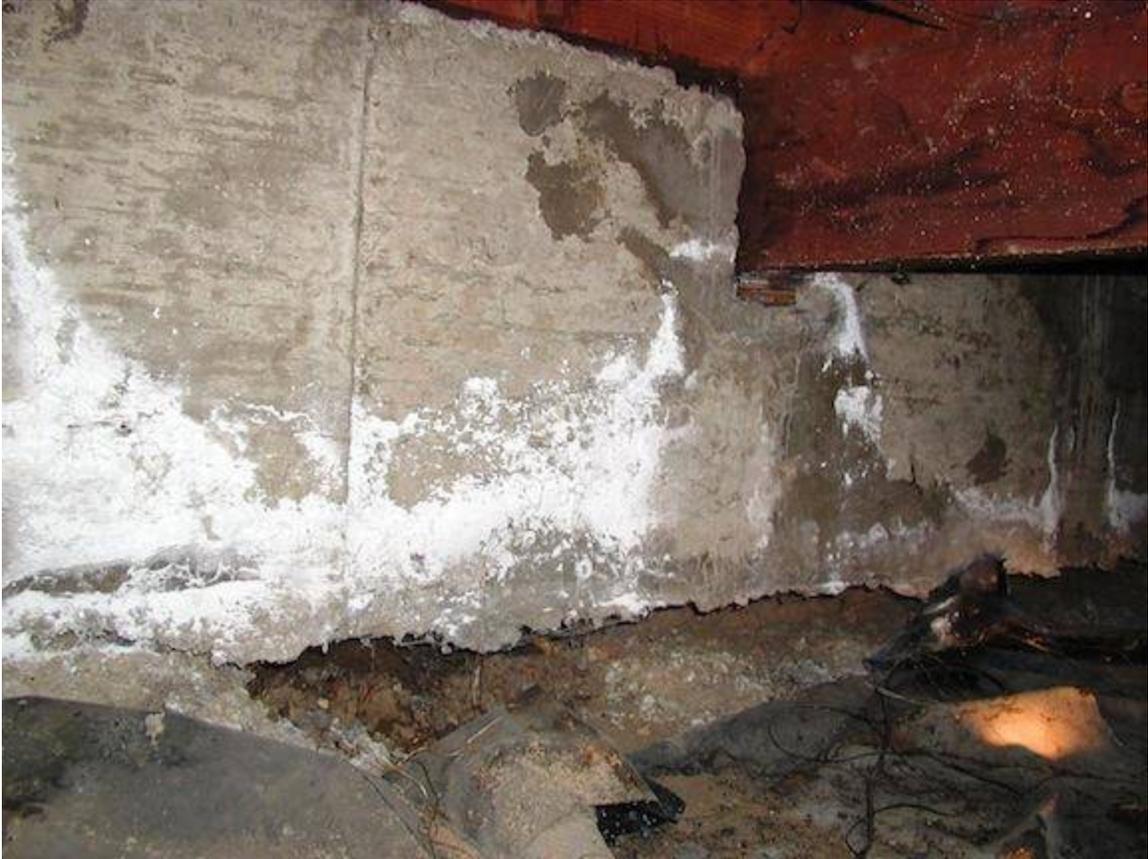
Severe efflorescence from downspout discharge

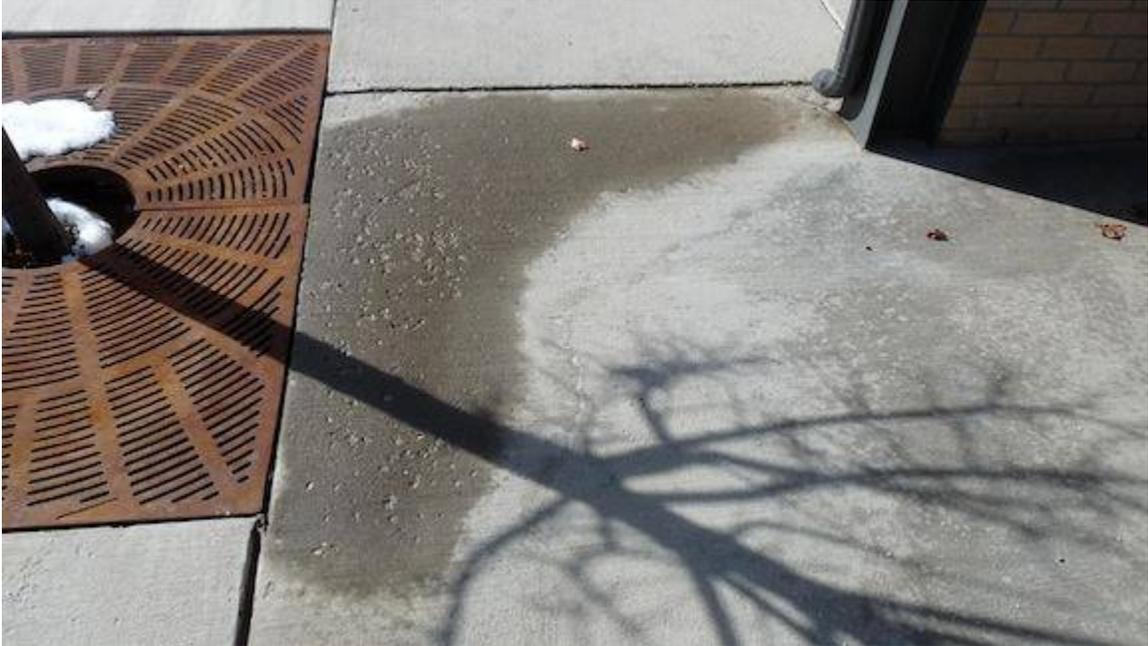
The location of damage reflects the amount of moisture exposure.

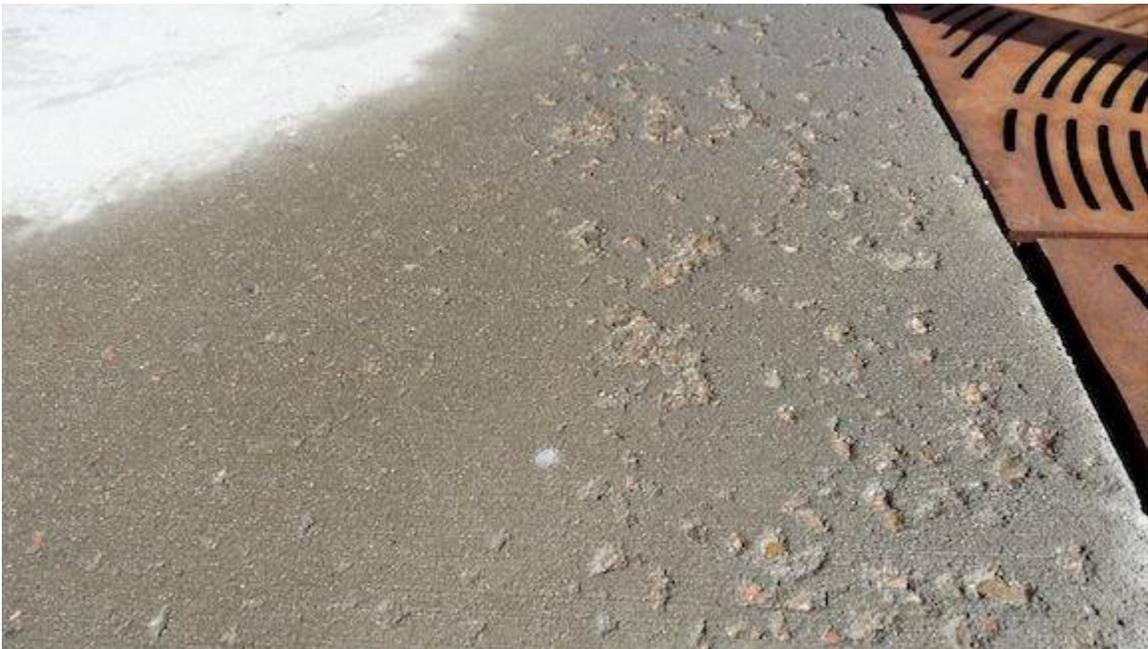
The lack of ruptured aggregate indicates that this damage was most likely caused by reactive aggregate.

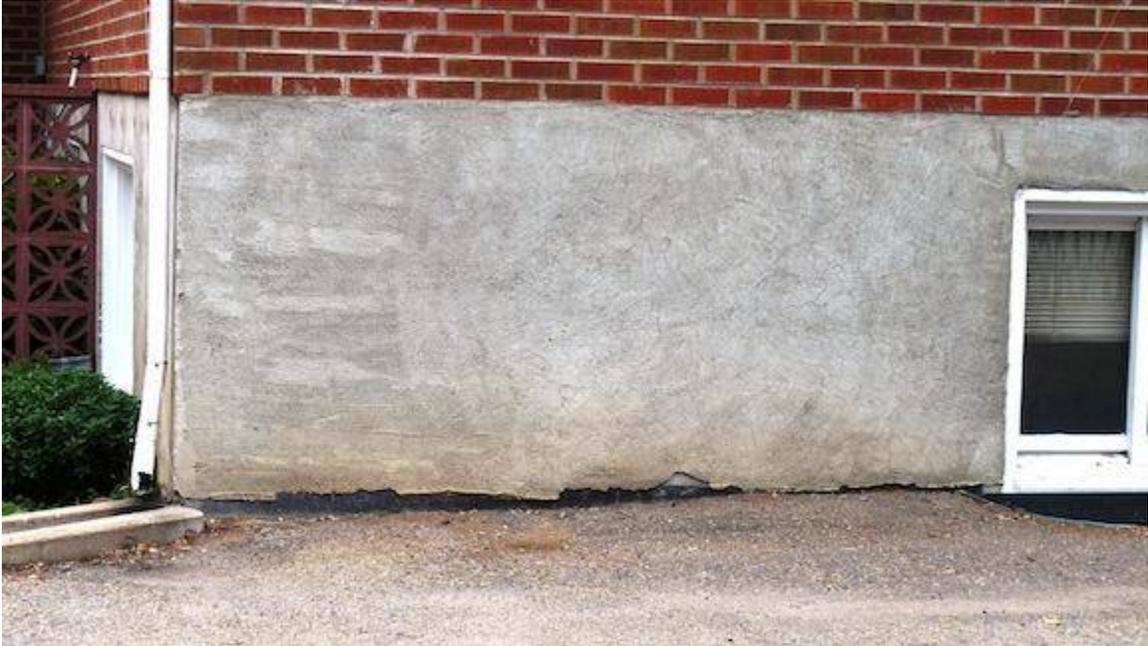
A parge coat showing widespread pattern cracking from excessive water in the mix or excessively fast drying, or both

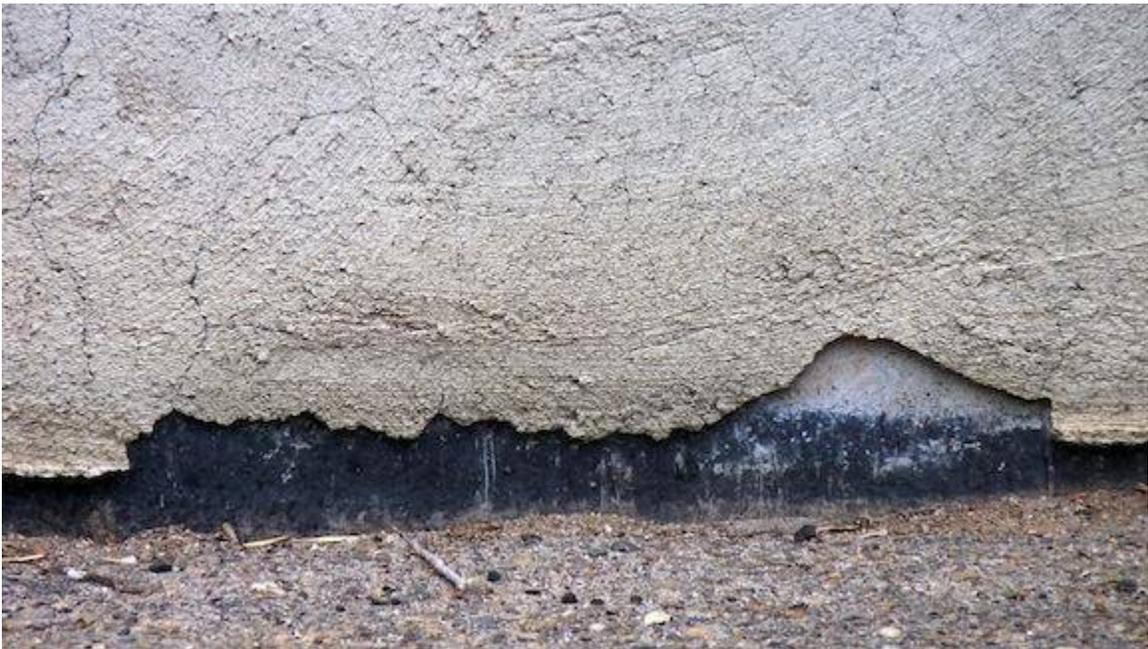
The photo above shows a close-up of the parge coat. The parge coat bond has failed and it has begun to delaminate from the underlying wall.
